GREAT FALLS TAVERN

Cultural Landscape Report

U.S. Department of the Interior
National Park Service
National Capital Region
Cultural Landscapes Program
Washington, D.C.
September 2009

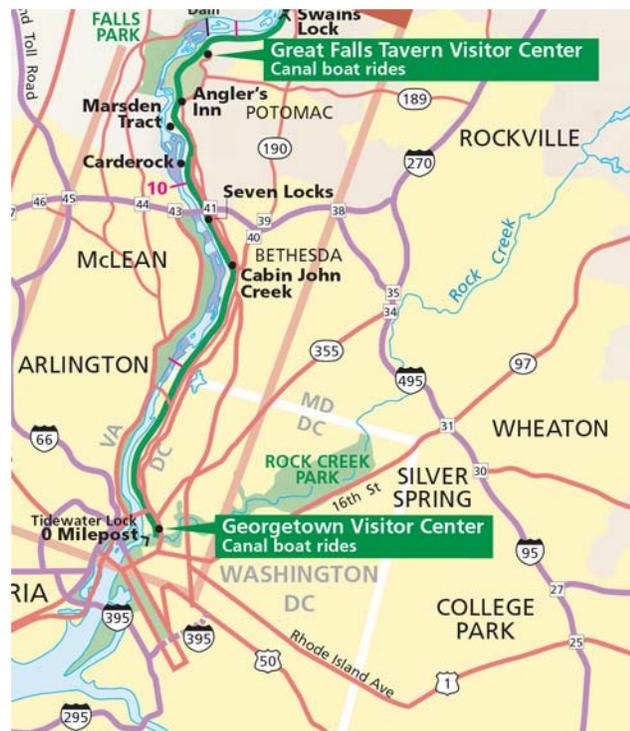
Figure 1 The C & O Canal from Georgetown to Swain's Lock (Lock 21), (NPS).

The Great Falls Tavern (GFT) property has been under the management of the National Park Service since 1938 when the federal government purchased land from the Baltimore and Ohio Railroad. The tavern is a component landscape of the Chesapeake & Ohio (C & O) canal, and was officially designated the Chesapeake & Ohio Canal National Historical Park in 1971 (Fig.1).

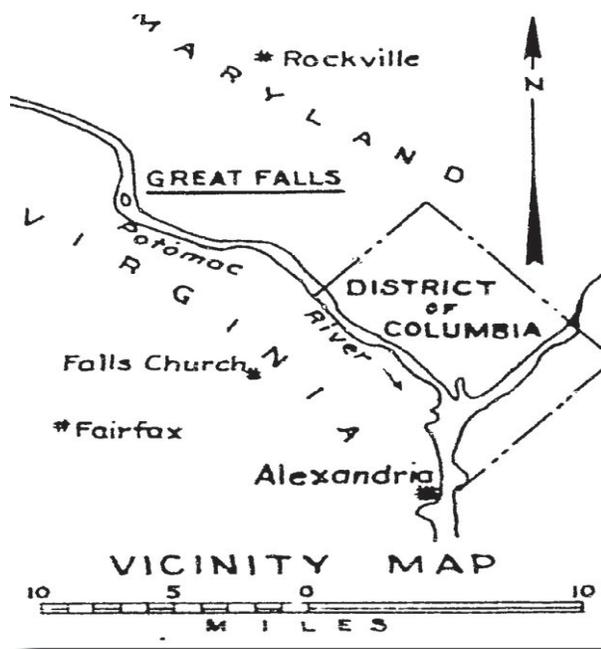
Figure 2 Map of the location of the Great Falls area (DSC TIC 412_80432).

The historic C & O canal comprises a linear tract that runs 184.5 miles from the Georgetown region of the District of Columbia to Cumberland, Maryland. The Great Falls Tavern is located in the Maryland piedmont approximately 15 miles north of Washington, D.C. (Figs 2, 3). Currently the site is a center for recreation, demonstration and interpretation. Historically the site has been a working industrial and commercial landscape. Under specifications established by the newly formed Chesapeake & Ohio Canal Company, the tavern at Great Falls was built in 1828 to house a Lock Keeper and his family. The structure rapidly expanded into a tavern and hotel after additions to the original stone structure were completed in 1831.

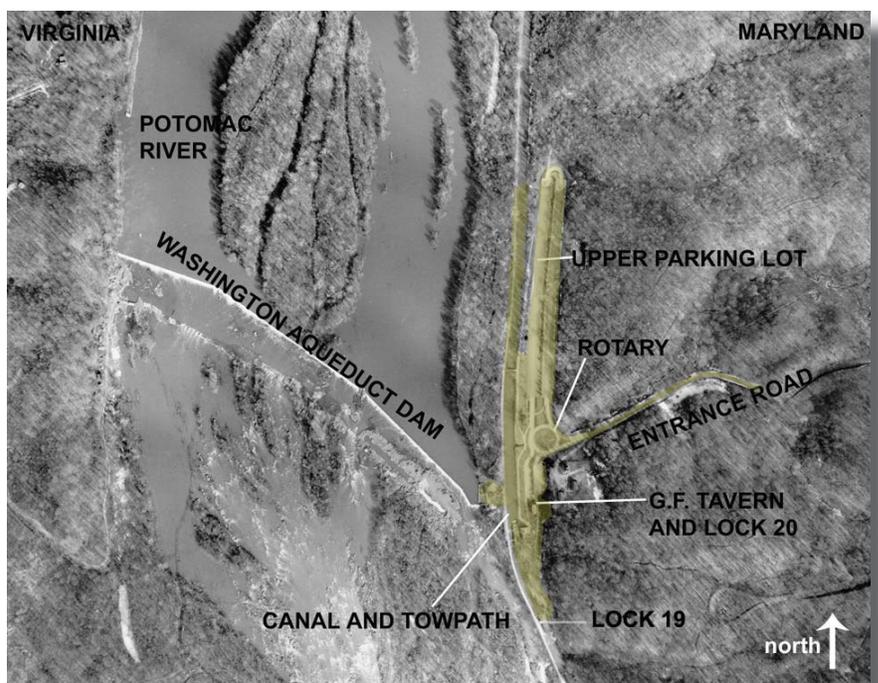
Figure 5 Plan view of Great Falls Tavern area. Study area is highlighted in yellow (CHOH aerial 1963).

Study boundaries established for the Great Falls Tavern (GFT) CLR include the immediate area surrounding the tavern, the parking areas, the canal prism, towpath and the entrance road. It is bounded to the north by the end of the upper parking area, and to the south by Lock 19 (Fig. 5). Areas excluded from the CLR include Olmsted Island, the Gold Mine Tract, the administrative area and the Palisades maintenance area.

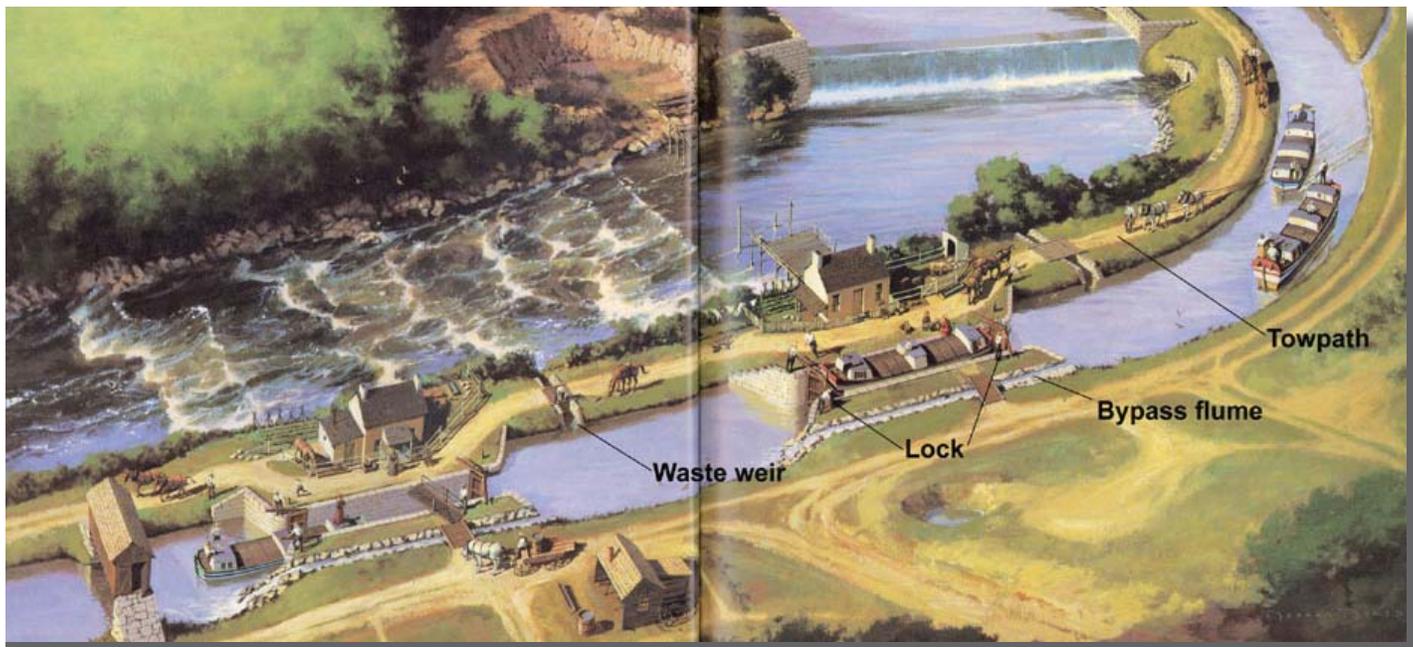
Figure 9 To maintain a 2-3 mph current and a 6' depth, canal builders used a precise system of building and water management (Chesapeake and Ohio Canal: Official National Park Handbook #142).

The canal was called a prism because it was about six feet deep and it was wider at the water's surface. Water levels and flow were controlled with feeder dams, which brought water in from the Potomac River. Culverts diverted streams under the canal to the Potomac. Bypass flumes helped to alleviate water pressure on lock gates. Waste weirs, built at the lower end of certain levels, allowed excess water to drain from the canal, and the locks themselves. Canal company specifications directed construction of all canal features. A towpath was built, generally on the river side of the canal, to allow passage of the mules or horses used for towing the canal boats. The surface of the towpath was constructed of six inches of packed broken stone to support pack animals pulling canal boats. Under the original design specifications, it was recommended that no wagons, carts or other wheeled vehicles were to traverse the pathway. Retaining walls of earth or stone were often constructed to separate the land and water. The opposite side of the canal was usually bermed (Fig. 9). A local exception to this rule was the area from Lock 18 downriver to the area known as Widewater, where a former river channel was used as a bypass route. Widewater had historically been susceptible to flooding and, along with the other parts of the canal and towpath, would flood several times in the future.

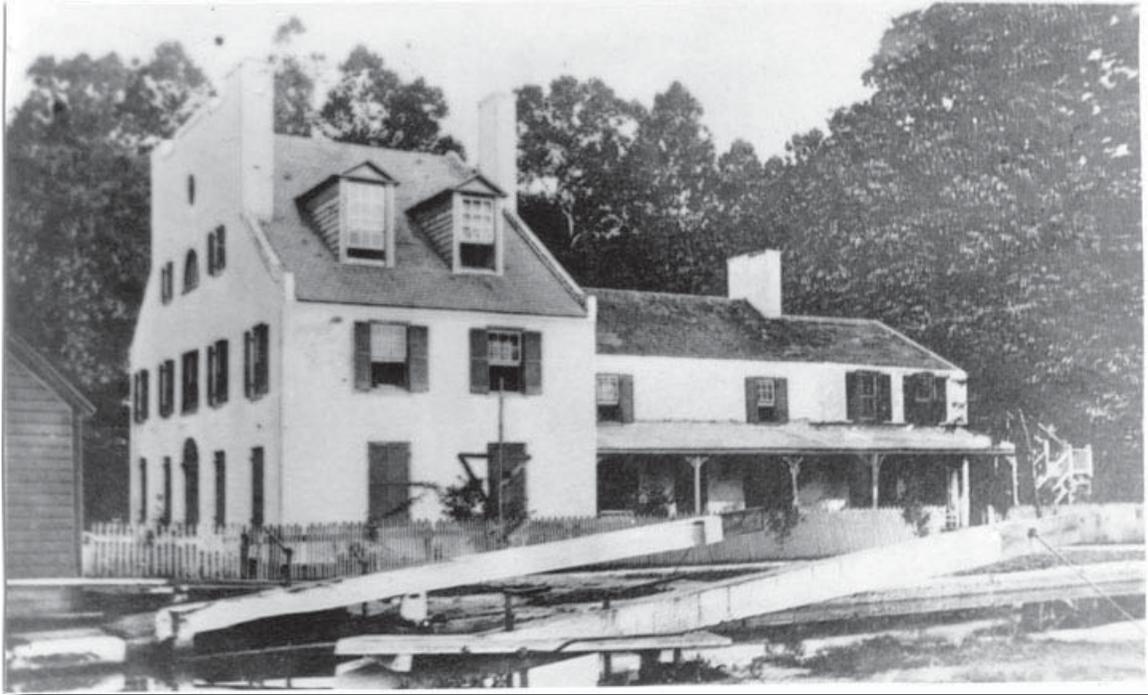
Figure 10 The Tavern at Great Falls (seen here c. 1900) was originally built in 1828 as a Lockkeeper's house. It was expanded into a Tavern in 1830 when additions were built on both the north and south sides of the stone core (CHOH Sharpsburg, Young and Jett, 5).

The Great Falls Tavern was initially built in 1828 as a Lockkeeper's house known as Lock House 12. It was a stone structure built to the specifications established by the C & O Canal Company. In November 1830 the company appointed W. W. Fenlon, a canal construction contractor, keeper of Locks 19 and 20. Additions to the Lockkeeper's house were constructed from 1830 to 1831 on both the north and south sides of the structure (Fig.10). During that year, the house was expanded to include a tavern. Further, the canal company granted Fenlon monies to construct a kitchen and an unspecified number of additional buildings.

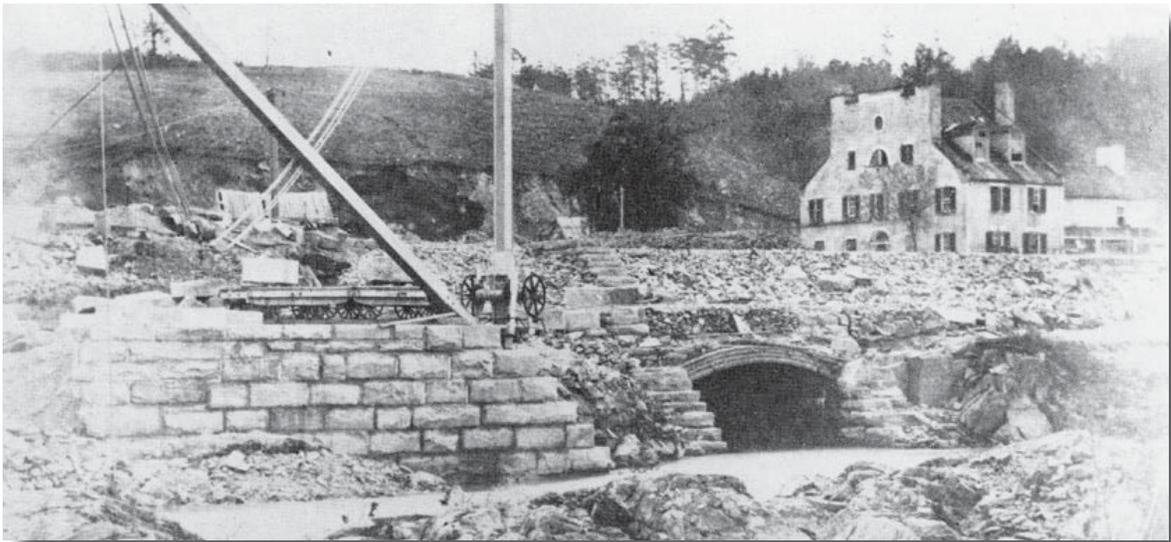
Figure 11 Construction of the Washington Aqueduct c.1870 (GFT Library).

The 1850s brought further change to the landscape of the GFT site, with the construction of the Washington Aqueduct, led by Lieutenant Montgomery C. Meigs of the United States Army Corps of Engineers. During his lifetime, Meigs was a well-known U.S. Army officer, civil engineer, and construction engineer recognized for his work on the dome and wings of the U.S. Capitol building, his Civil War service and his design of the Pension Building (current National Building Museum), among others. The aqueduct would provide water from the Potomac River to Washington, D. C., located approximately 15 miles away (Fig. 11).

The Corps extended a masonry dam to Olmsted Island in order to impound and direct water into the aqueduct. An intake dam was located on the riverbank directly across from Lock 20 where a deep channel and gravity directed water into a tunnel under the canal, and through a 1,432-foot tunnel blasted through the rock east of the tavern. The tunnel terminated at Angler's Inn at Conduit Road (modern MacArthur Blvd.). From there, water traveled through a sturdy aqueduct of brick, stone and mortar along the Palisades and to reservoirs in Georgetown.

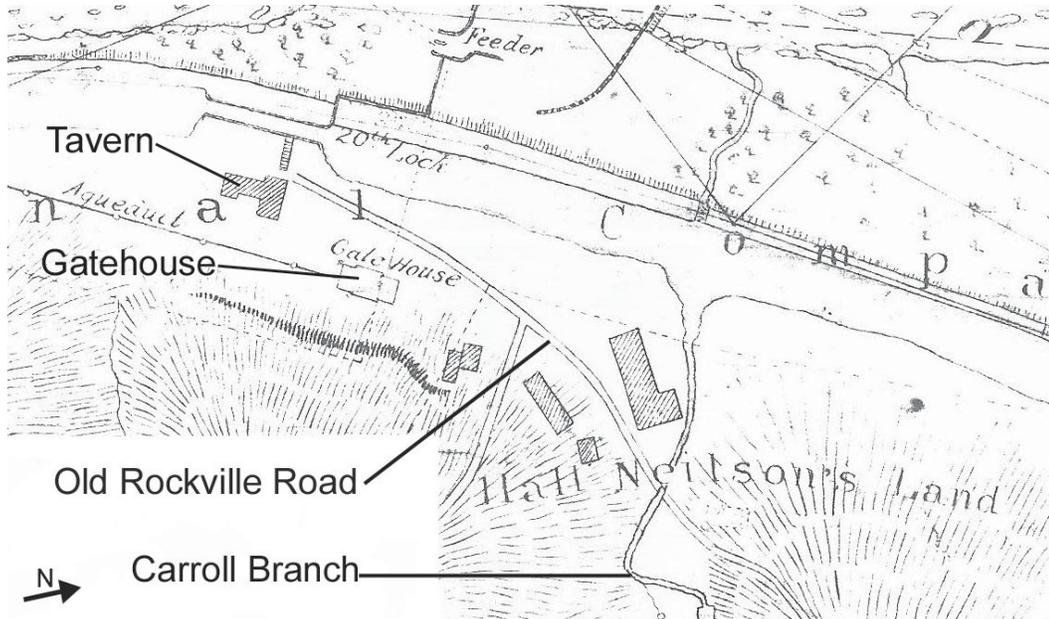
Figure 12 This 1858 map illustrates the locations of buildings along the Old Rockville Road (H Neilson Fisheries Map, 1858).

During the initial construction in the GFT area, the orientation of the built landscape was towards the canal, towpath and river. The tavern, and later the aqueduct gatehouse, were constructed and oriented to support and maintain activities towards the river and towpath. Later, the constructed elements at Carroll Branch and the Old Rockville Road, which no longer exist, strayed from canal orientation. These were situated towards both the Old Rockville Road and the Entrance Road to ease transportation, and to access water from the well near Carroll Branch (see Fig. 12).

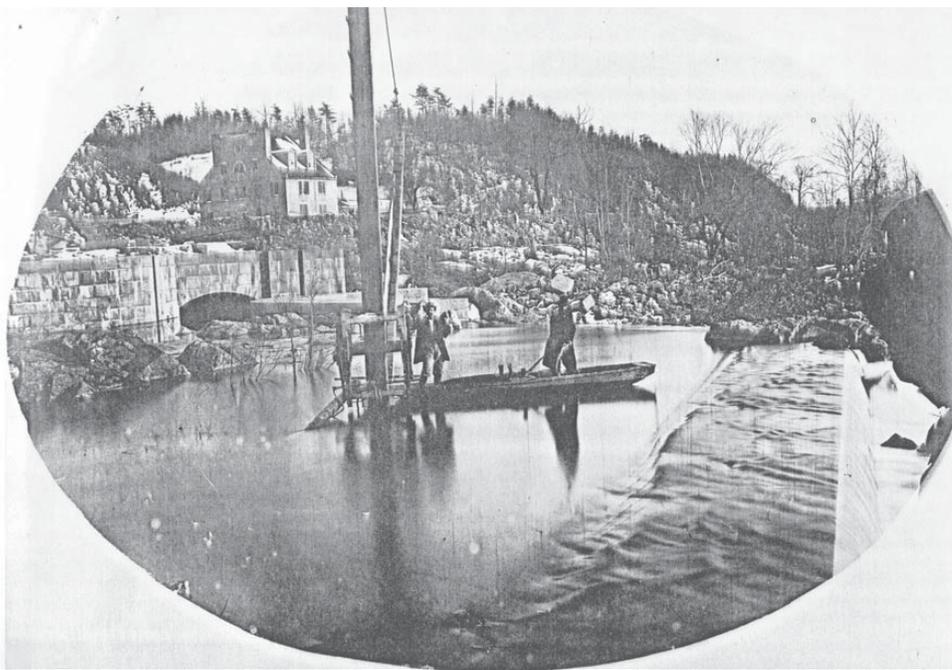
*Figure 15 The intake at the Washington Aqueduct c. 1900 with
Great Falls Tavern in the background (GFT library).*

From 1884 to 1885, the local population boomed, when five hundred workers were stationed at the GFT area. They worked to extend the dam to the Virginia side of the Potomac, in order to raise it to 148 feet above sea level to divert enough water to supply the growing D.C. metropolitan area. Workers also raised the towpath and built fish ladders, which are said to have never worked properly, to the east of the falls (Fig. 15).

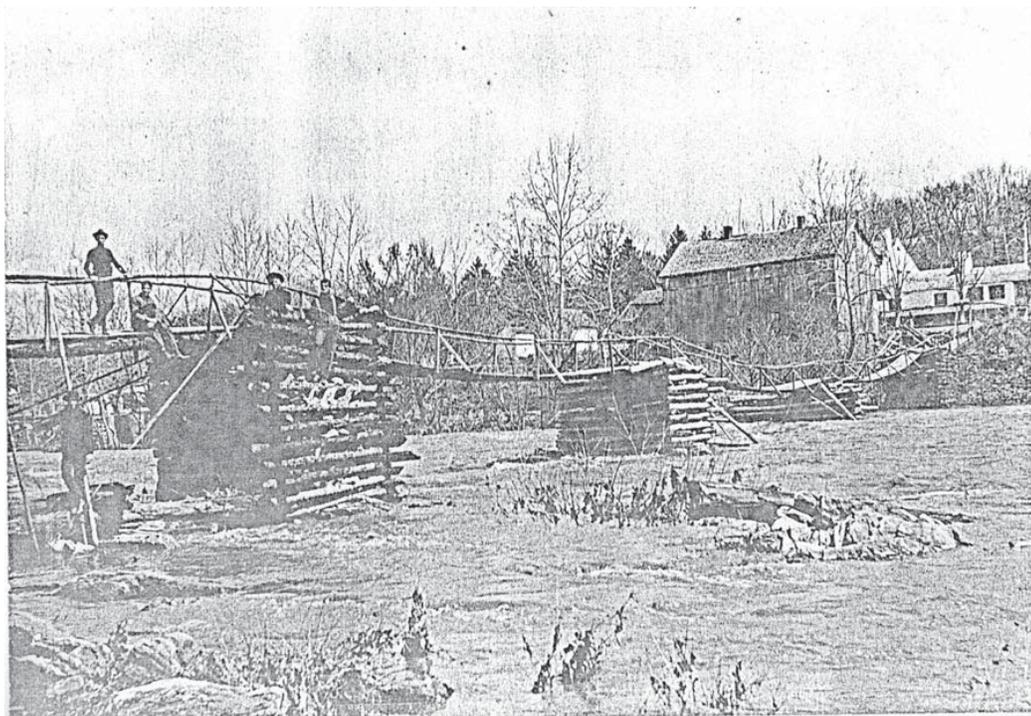
Figure 16 A photograph from the late 1800s shows one of the many bridges that were frequently destroyed in floods leading from the canal to the falls. On the right-hand side of the picture, Garrett's store, which was on the towpath side of the canal and part of the Tavern, can be seen (CHOH Shoup collection).

During the late 1800s, guests came to the area by stage line, steam packet, canal boat and ferries. The 1865 extension of the Conduit Road (currently known as the Entrance Road) increased the influx of tourism to the GFT area. In 1880, a wooden semi-suspension bridge led visitors to Falls Island (modern Olmsted Island) from the southern end of Lock 20 (Fig. 16). Some of the favorite visitor activities were fishing for shad and bass, viewing the falls by moonlight, or watching the winter ice traverse the falls in early spring. High waters washed the footbridge away but it was quickly replaced to please visitors and to keep up the area's reputation as an extraordinary destination.

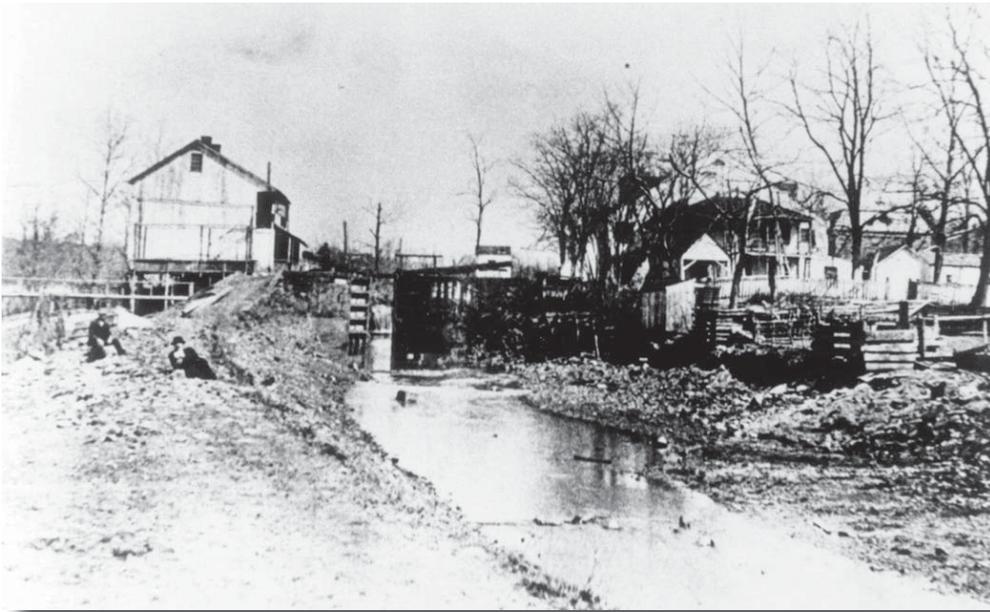
Figure 17 The canal at Lock 20 after a flood event. Notice Garrett's store on the topath side of the canal (CHOH Sharpsburg Young and Jett, 2).

In June of 1889, disaster struck the canal with immense flooding. The rains and high water wiped out the basement of Garrett's store, damaged the tavern and aqueduct, and washed away the bridge to Falls Island (Fig. 17, 18). The canal company could not afford to fix the damages and went into receivership to the Baltimore & Ohio Railroad (B & O), who completed needed repairs by 1891. Due to the nation-wide growth and speed of rail conveyance, general canal trade diminished in the late 19th century with the exception of the transportation of coal.

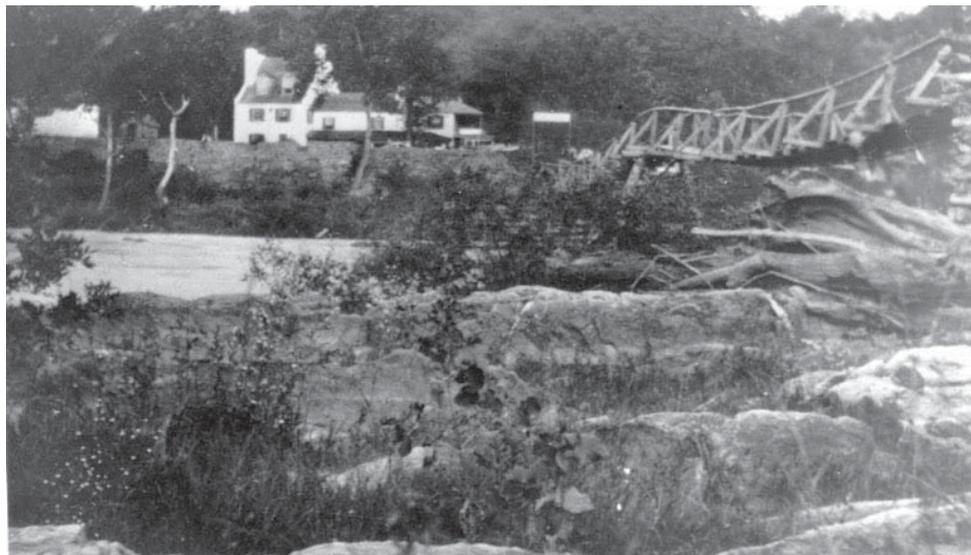
Figure 18 New foot-bridge to views of the Great Falls from Lock 20 c. 1900. Note, Garrett's store no longer extant (CHOH L20-19).

Two years later, the trolley tracks, which served the Washington and Great Falls Railway and Power Company, were removed from the site. Later, in 1936, the footbridge to Falls Island was washed away again, and replaced within the same year (See Fig. 18).

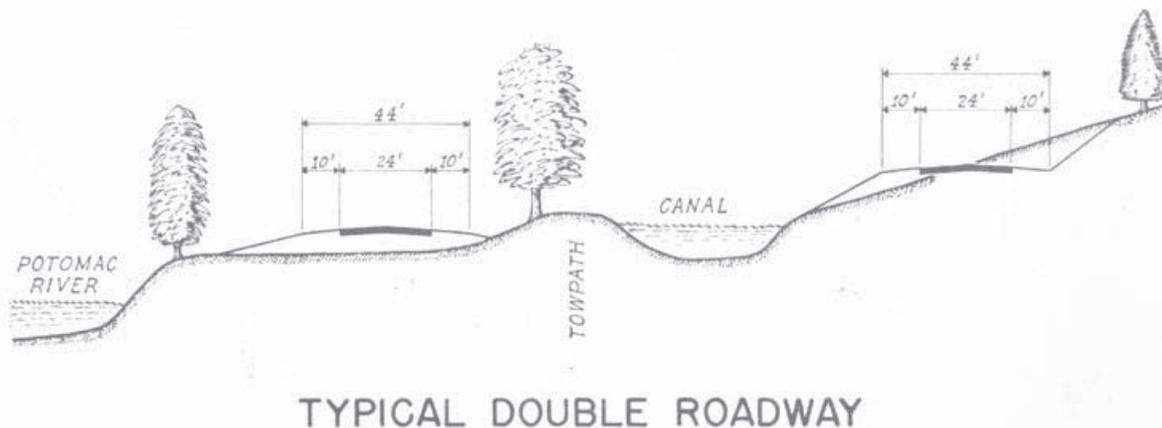
Figure 21 Sketch from 1948 report by the NPS and the Bureau of Public Roads on advisability and practicability of constructing a parkway along the canal route (Report on Joint Reconnaissance Survey and Study by the BPR and NPS p. 53).

In 1939, the Bureau of Public Roads (BPR) rejected upgrading the Entrance Road (formerly known as Conduit Road), for the highway, proposed by the National Capital Park and Planning Commission (NCPPC). Expanding on the NCPPC plans, the BPR proposed plans for a modern 4-lane highway along the canal (Fig. 21). Oscar L. Chapman, then Secretary of the Interior, stated in a December 19, 1949 letter to J. Hardin Peterson, Chairman, Committee on Public Lands, House of Representatives:

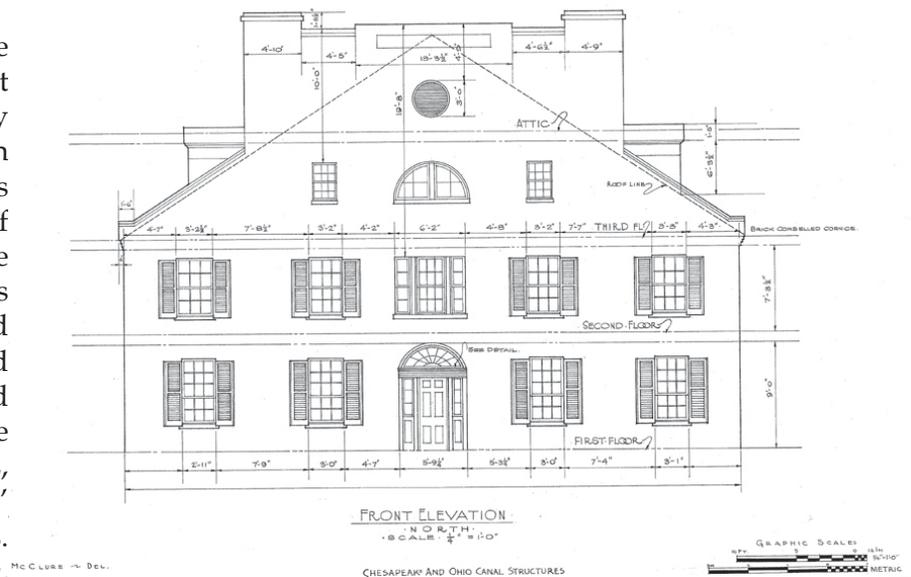
Figure 22 Historic American Building Survey (HABS) drawing of the Great Falls Tavern c.1930 (Library of Congress American Memory Collection).

In the 1930s, research had become so extensive that in the 17 months ending June 1, 1936, over 300 reports had been prepared. “The reports made as a result of inquiries from the field and other branches of the Park Service...are indispensable to the authentic development of the sites under Federal Administration. Accurate restoration of historic buildings is often made possible only by data uncovered in the Library of Congress and other governmental agencies...”⁴² (Fig. 22).

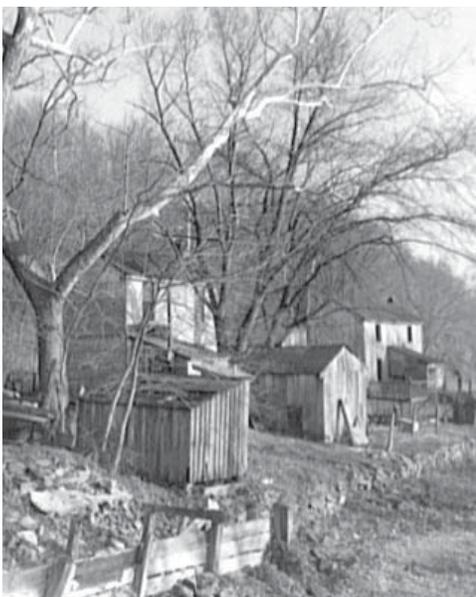
Figure 23 Historic photograph of wooden structures on the berm bank south of the Tavern between Locks 19 and 20 (Library of Congress American Memory Collection.).

The NPS surveyed needed architectural work in 1939. No use had yet been determined for the tavern, which was in poor condition. Vint wrote: "Until the best use for this building that has provided food and shelter on the canal for the greater part of a century is determined, only the most sorely needed repairs to save the building from further dilapidation are to be made."⁴⁷ A log house to the southeast of the tavern was to be "put into good condition" and used as a "tender's dwelling", "its original purpose". Evidently, the log house was well built. The current resident "consider(ed) it comfortable, as the thick log walls keep it cool in summer and warm in winter."⁴⁸ Two late 19th c. frame houses were considered to be of "no importance, either historically or economically to the canal." They were to be razed and the salvaged material applied to other buildings (Fig. 23).⁴⁹

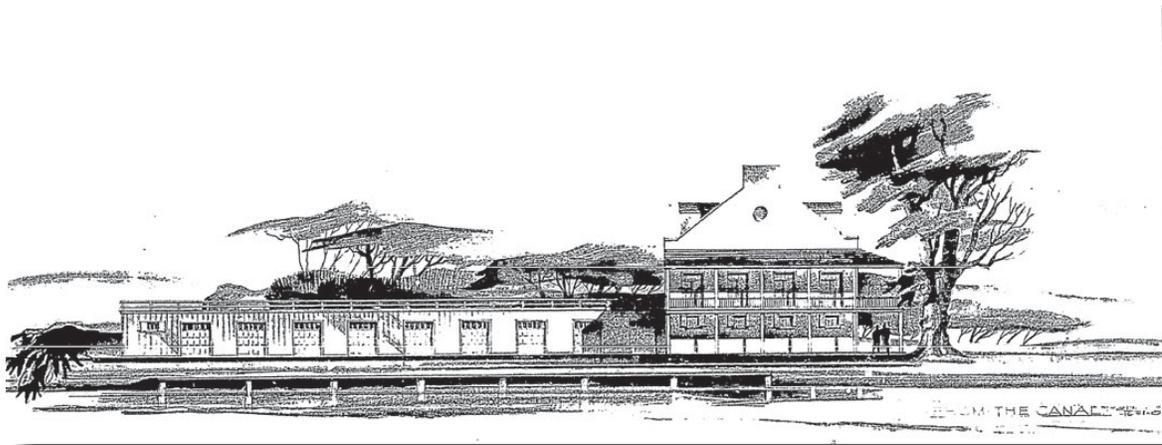
Figure 24 1939 drawing of a proposed Canoe house and Concessions at Great Falls, MD by the Washington, D.C. Office of Plans and Design (DSC TIC 412_80489).

Great Falls was one of the nodes planned for heavy visitor use, year-round. Planners estimated the area would accommodate 2,000 people, all of whom were expected to drive there. Adequate parking was “imperative.” Acquisition of additional land for parking and buildings would “realize the maximum use” of the Six Locks area. The proposed buildings included a two-story stone structure resembling the tavern, with separate men’s and women’s lockers, toilets below, and kitchen and dining room above. Attached to this was a one-story frame building with a roof deck for dining, promenades or games. It would store 100 canoes and bicycles. Drawings show that the NPS planned to build these on the berm northeast of the tavern (Fig. 24).

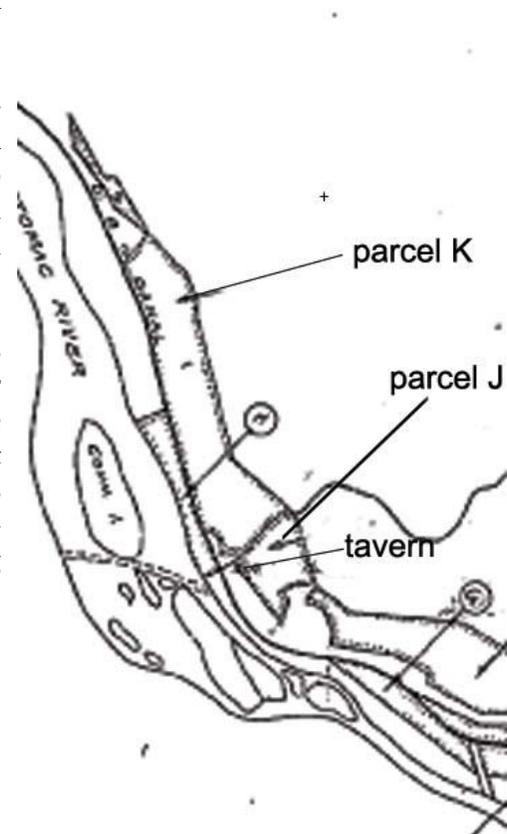
Figure 26 Parcels J and K were part of a land acquisition transacted by the GWMP division of the NPS in the mid 1940's (Land order deed 11/14/1944).

In the 1940s, the NPS approved plans and commenced construction of the parking lots, the circular drive and other site elements. A long, thin strip of land on the east bank of the canal just north of the aqueduct parcel (Fig. 26 [previous page], parcel K) had been acquired for the parkway by a deed recorded in 1944. This parcel provided the basis for the design of the parking along the canal. The long, linear parking lot could accommodate approximately 600 cars; it was made of compacted gravel, and remained unpaved until 1963. (Fig. 27)

The parking areas were designed by the NPS in the 1940s on two levels each with one-way aisles to fit within the shape of the original parcel purchased by NPS as an extension of the George Washington Memorial Parkway (GWMP) in 1944 (See Fig 26). The layout and dimensions of the lots are the same now as when they were paved and graded in the mid 20th century. Lot elevations extend from 190 feet at the northeast side of the upper parking area to about 155 feet at the bank on the south side of the tavern with a gradient of 2 percent in a little less than a half mile.

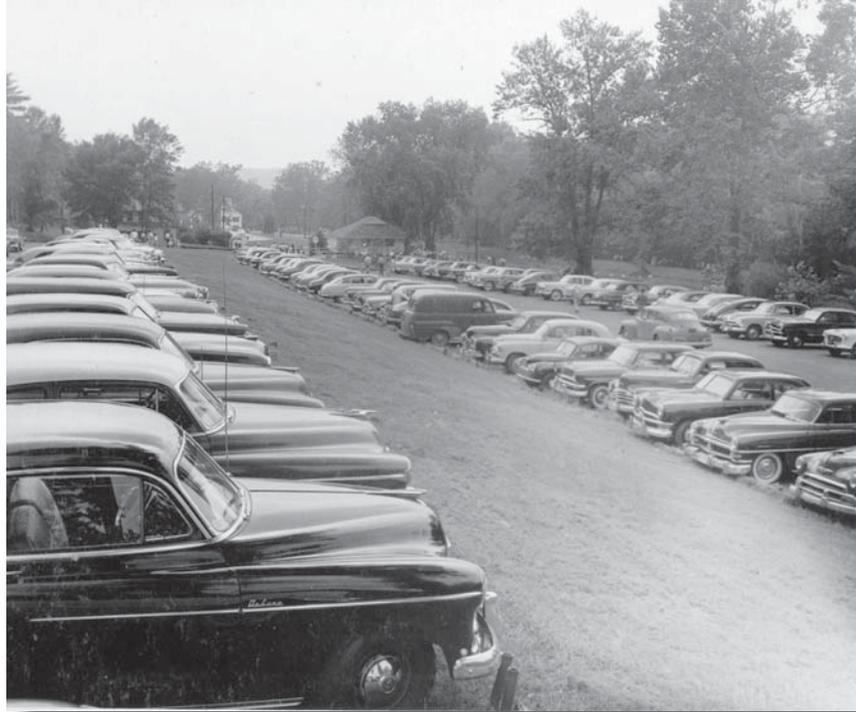
Figure 27 Parking lots at Great Falls Tavern alleviated long back-ups and visitor parking along the entrance road. This is a photograph from the 1950's, before the parking lots were paved (CHOH).

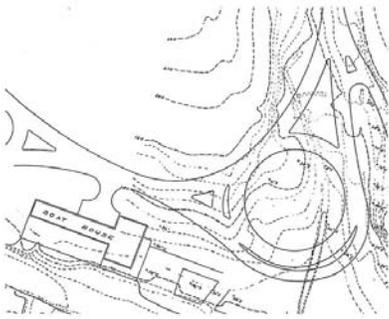
The 1938 plan is one of the first drawn up for the rotary feature at the Great Falls Tavern.

Figure 28 (above) The notion of a rotary at the GFT parking lot was conceived long before it was realized. Several design iterations showed the rotary in many forms (DSC TIC files 412_80434, 412_80491, 1940 Plan Parkway, 412_80462, 412_80473, NPS).

By the end of the 1950s, the NPS completed construction of the traffic rotary, marking the terminus of the Entrance Road at GFT. NPS designers envisioned the rotary as a principal terminus of the C & O Canal Parkway, the project that was never realized. The terminus design grew out of several iterations from 1938 through the 1950s, as shown in NPS plans of that era (Fig. 28).

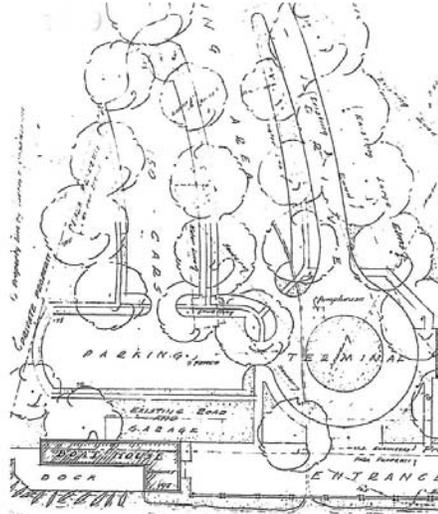
1939

The parcel of land upon which the current parking lot lies was not yet owned by the parks in 1939. Planners proposed an east, west oriented lot buffered from the entry road by large trees

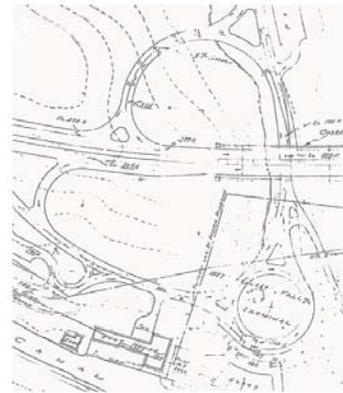
The 1940 plan includes the relationship between the rotary and a proposed parkway.

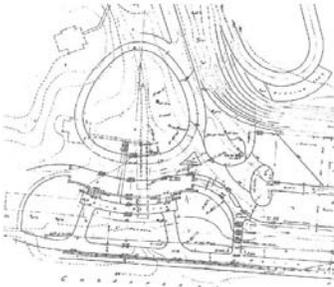
In 1942 the rotary took on an egg-shaped form.

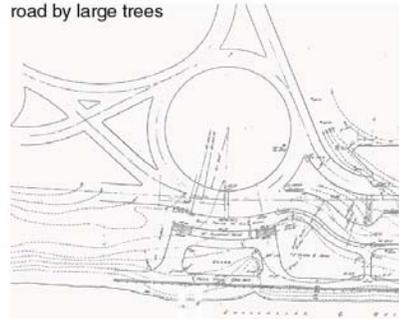
1948

By the Late 1940's, the rotary design reverted back to a circular arrangement.

The current rotary design is based on a plan conceived in 1948.

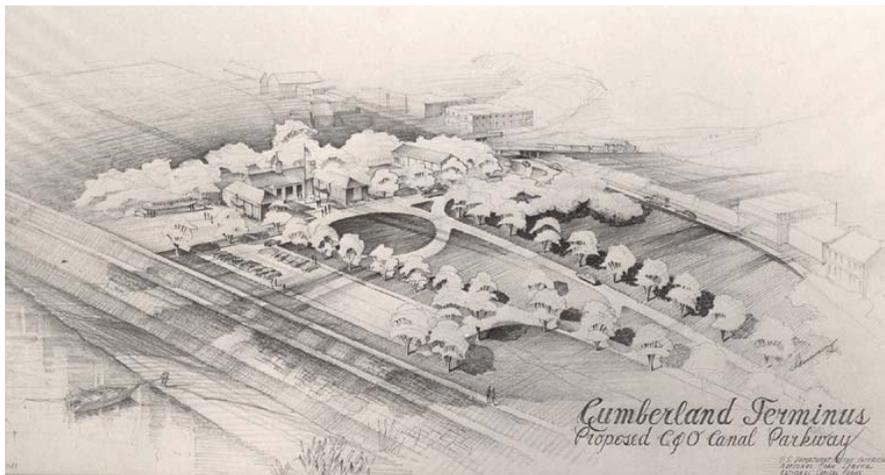
Figure 29 (left) Proposed parkway terminus at Cumberland, Maryland was never realized since the proposed parkway was defeated by conservationists (Report on Joint Reconnaissance Survey and Study by the BPR and NPS p. 46).

The federal government purchased the canal in the 1930s. Its linear nature and scenic views along the corridor were driving forces in parkway plans generated within the 1901 McMillan Plan, and authorized by the Capper-Crampton act of 1930. Modern-day evidence of this parkway use is in the existence of the rotary terminus feature which separates the upper and lower parking areas. Rotary designs were a popular design element at the time and this is highlighted by the rotary at Mount Vernon in Virginia, along the George Washington Memorial Parkway (GWMP) near Alexandria and in plans for the canal's terminus at Cumberland, Maryland (see Figs 28, 29).

The rotary design derives from plans for a parkway along the canal. The rotary feature is seen in several forms in numerous preliminary iterations of landscape development for the site prepared by the NPS during the 1940s (See Fig. 29). Rotaries had been a popular element of NPS planning since the late 1920s, when loops and rotaries were tools used by NPS planners to manage traffic flow and promote safety. Within the parks, they are found at the end of roads, overlooks and viewpoints, parking areas and inter-sections.

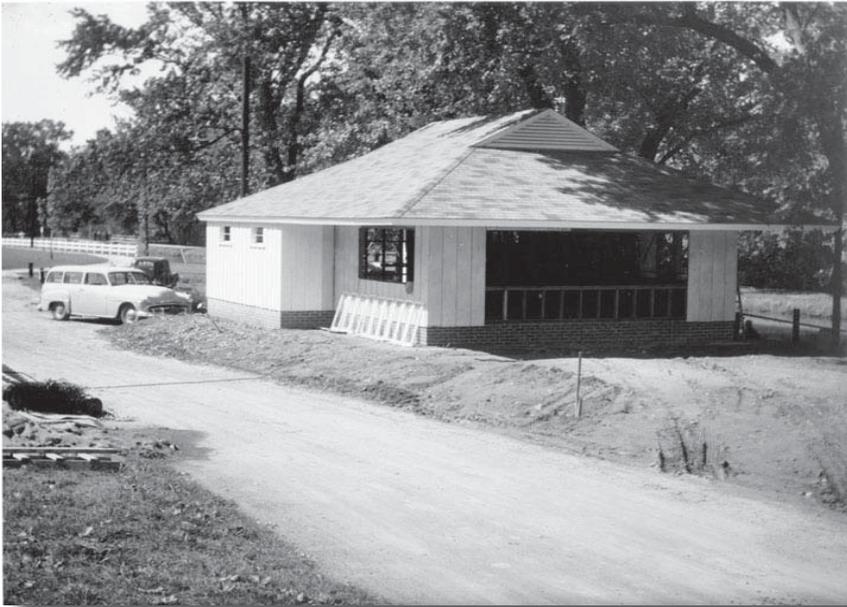
Figure 30 Photo of the Concession stand at Great Falls Tavern shortly after construction (CHOH).

During this period of recreational improvements, the park built the extant concession stand just north of Carroll Creek, a utility building in the maintenance yard to the northeast of the project area and two brick ranch houses near the stone and brick gatekeeper's house on the hill to the east of the control gatehouse. The location of the concessions building next to the Rotary was determined during numerous design modifications between 1939 and the early 1950s, as the canal parkway recreational concept developed (Fig. 30). The NPS originally designed a brick terrace on the north side of the concession stand to preserve existing silver maples that lined the berm bank. Landscape designs for the nearby picnic grounds and promenade were developed and constructed shortly after concession building was built (Fig. 31). Many larger existing trees and some shrubs date from these designs. Many others, including several around the concession building, are volunteers.

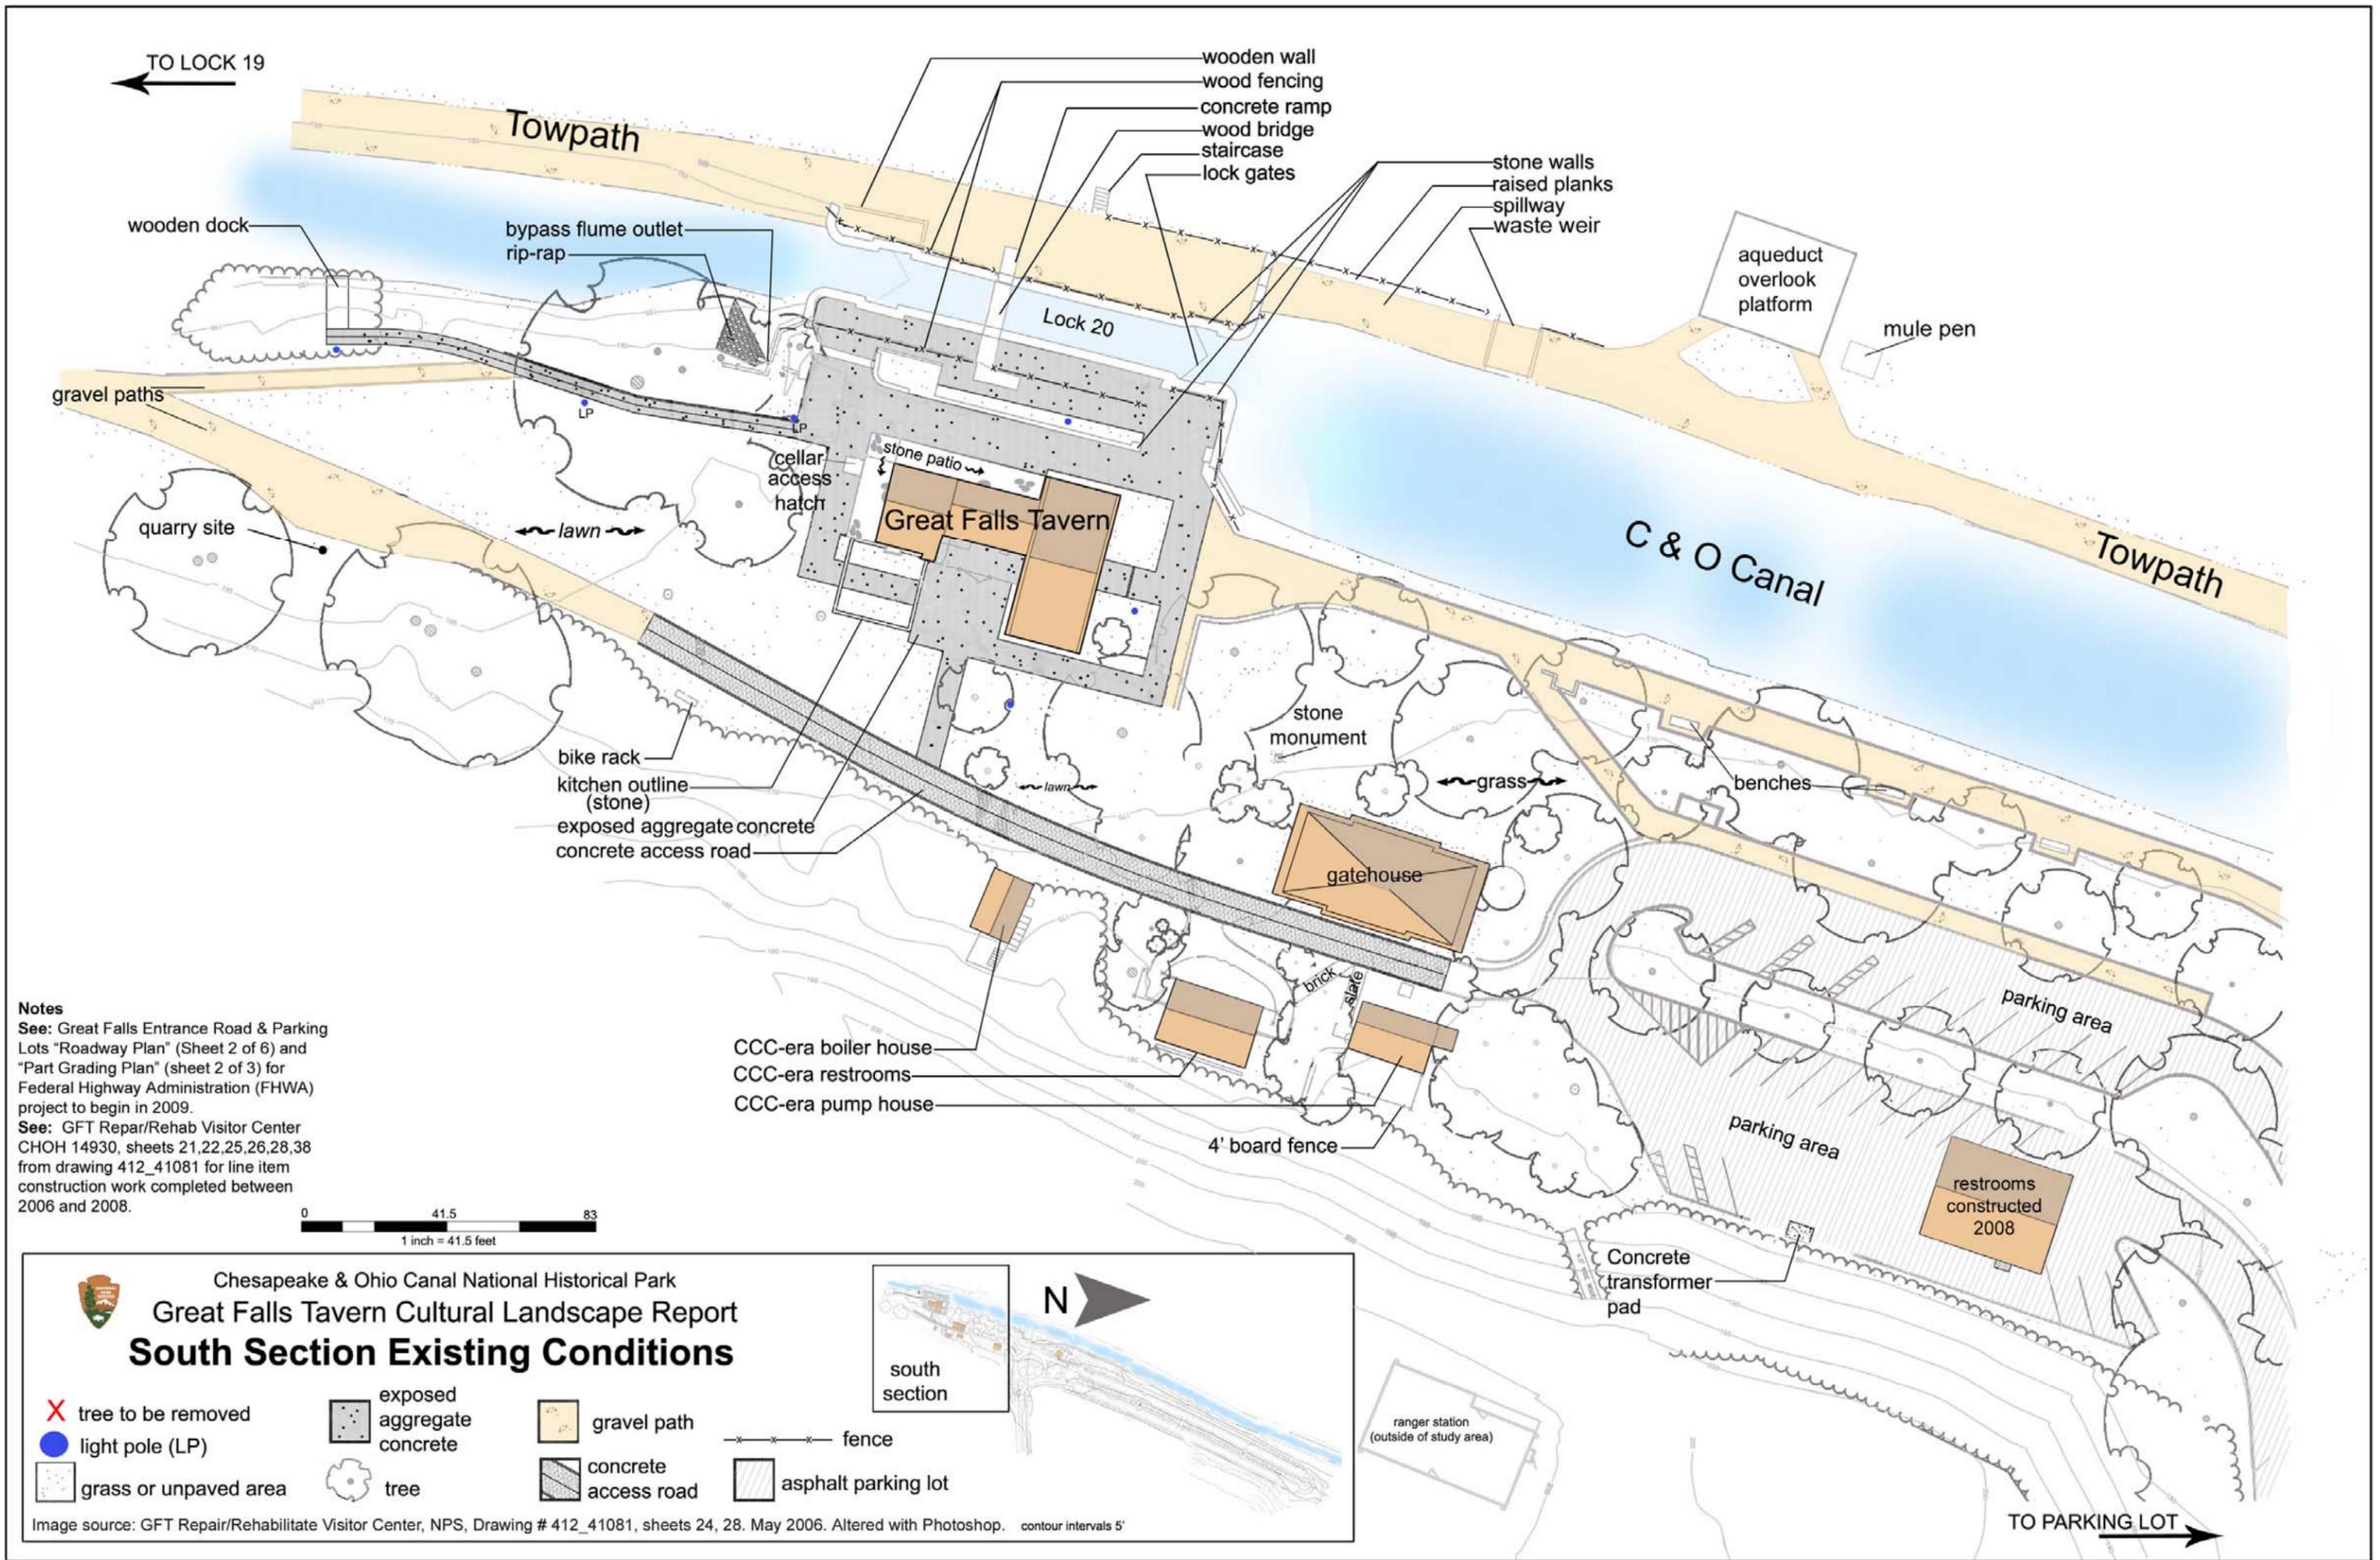
Chesapeake & Ohio Canal National Historical Park
Great Falls Tavern Cultural Landscape Report
South Section Existing Conditions

Notes
 See: Great Falls Entrance Road & Parking Lots "Roadway Plan" (Sheet 2 of 6) and "Part Grading Plan" (sheet 2 of 3) for Federal Highway Administration (FHWA) project to begin in 2009.
 See: GFT Repair/Rehab Visitor Center CHOH 14930, sheets 21,22,25,26,28,36 from drawing 412_41081 for line item construction work completed between 2006 and 2008.

Image source: GFT Repair/Rehabilitate Visitor Center, NPS, Drawing # 412_41081, sheets 24, 28. May 2006. Altered with Photoshop. contour intervals 5'

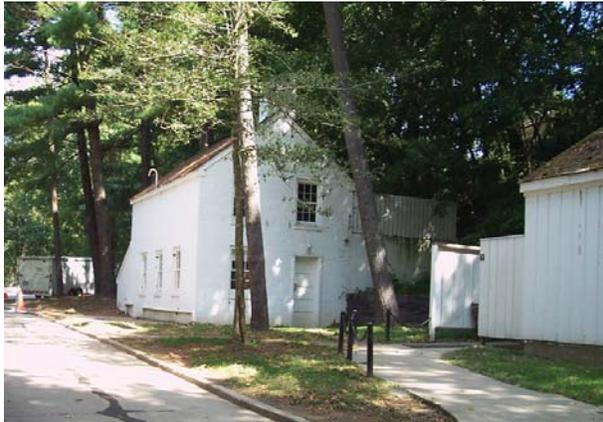
Figure 35 (left) WORKMANSHIP/LOCATION: CCC-built structures at the GFT (NCR CLP).

Later, adding to the density of structures in the lock area, the stone aqueduct gatehouse was installed. By the time that the CCC was established and working in the area in the 20th century, many of the structures in the Lock 20 area were no longer extant. The CCC did, however build a boiler house, a pump house and a comfort station to the northwest of the tavern at the base of the hill. All of the CCC structures exist today and lend integrity to the historical spatial organization of the Lock 20 area (see Fig. 35).

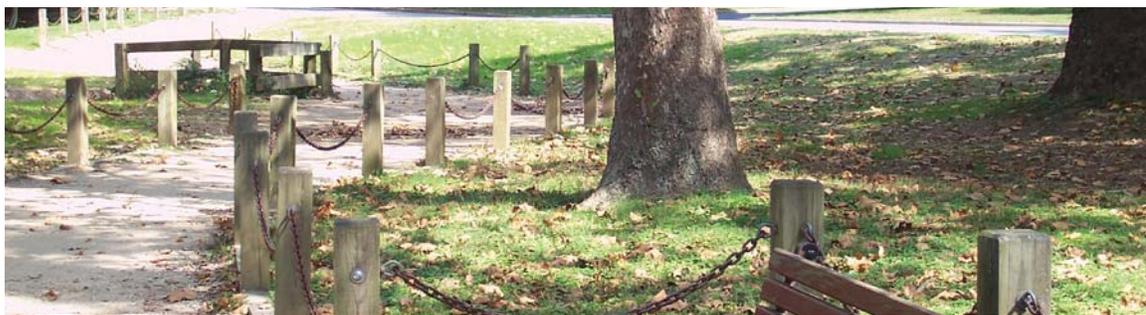
Figure 41 (above) Post and chain fencing as seen along the promenade between the concession stand and the tavern (NCR CLP 2006).

During the period of significance, varied usage and ownership led to "internal patterns of separation."⁶⁵ This refers to the use of fences and posts to demarcate property and ownership rights within the study site. Existing post and chain barriers installed along walkways by the NPS do not contribute to historical separation of uses on the site as fences once did. (Fig. 41).

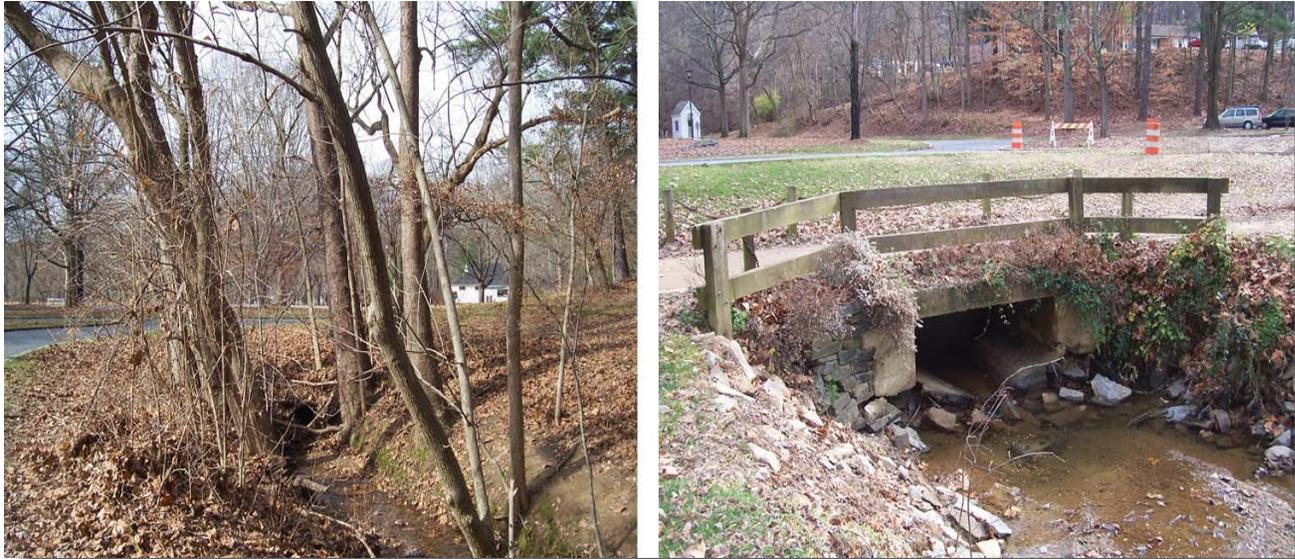
Figure 42 (above) Carroll Branch enters a culvert to the north of the Entrance Kiosk and runs under the Rotary to exit into the canal (NCR CLP 2006).

The forested land that includes the Entrance Road corridor is characterized by varied topography penetrated by internal drainage to the river shore. The elevation at the entrance at Falls Road is about 380 feet, dropping to about 180 feet at the entrance kiosk. The major drainage system north of the Entrance Road is Carroll Branch, which also accommodates drainage locally and from an area of low-density housing to the east of the site. South of the Entrance Road, several steeply-graded swales flow toward Carroll Branch. These suggest that the lower, western end of the road was built in line with the Carroll Branch floodplain. The western end of Carroll Branch flows through a double culvert, under the rotary, and outlets into the canal. The culvert was constructed in the mid-1950s. (Fig. 42).

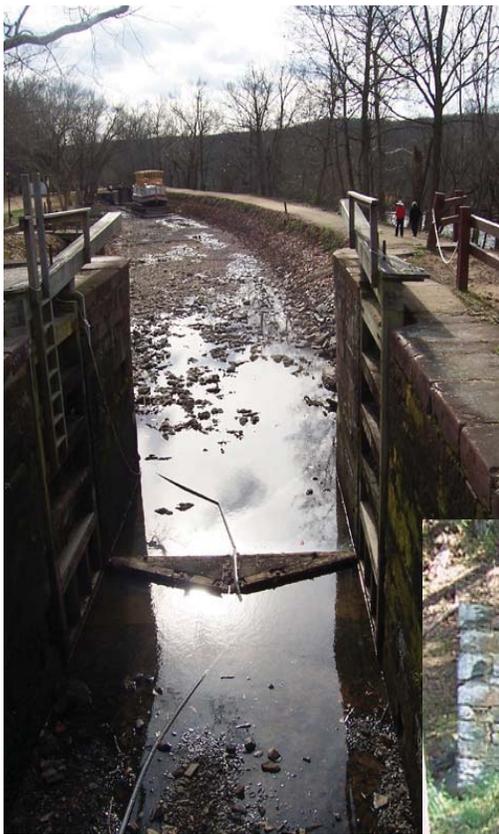
Figure 48 (left) The canal prism and walls at Lock 20 exist in their original alignment (NCR CLP 2006).
