GREAT FALLS TAVERN

Cultural Landscape Report

U.S. Department of the Interior
National Park Service
National Capital Region
Cultural Landscapes Program
Washington, D.C.
September 2009

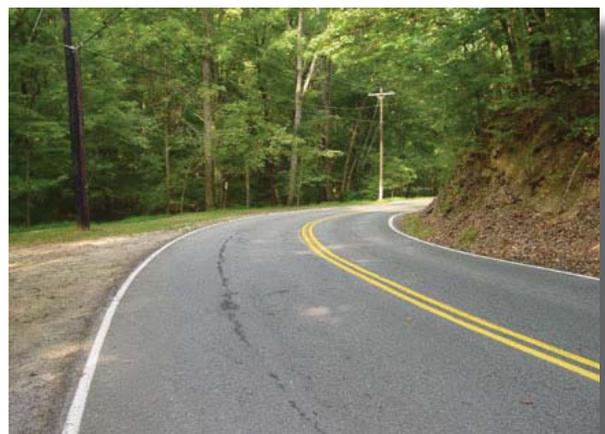
Figure 51 Steep banks, narrow travel lanes and curving paths are characteristic of the historic Conduit Road alignment (NCR CLP 2004).

This roadway is currently composed of two travel lanes, with undesignated paved or unpaved shoulders that drain to adjacent paved or vegetated swales (Fig. 51). The existing road surface is generally good, except in areas where freezing and thawing of surface water has started to break up the pavement.

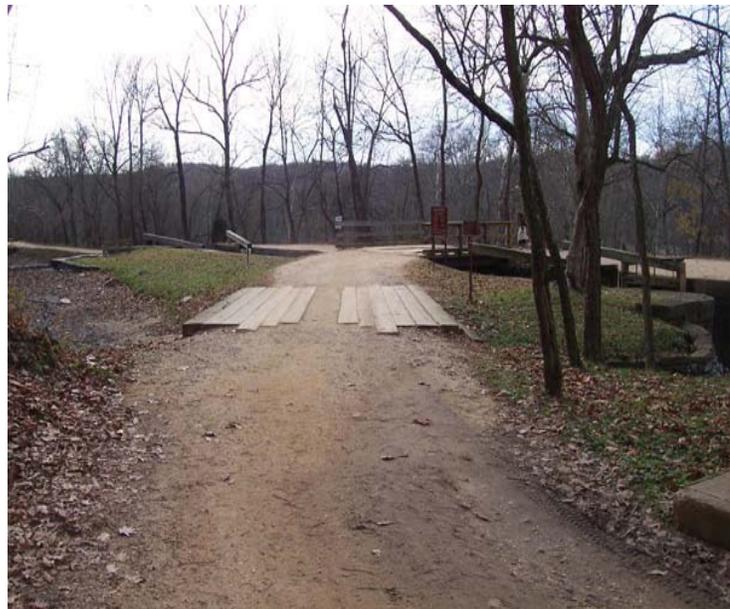
Figure 53 (below) The crossing at Lock 19 (NCR CLP 2006).

Beyond the lower parking area, to the south, is the second principal road system. This is restricted to service vehicles such as NPS staff, the Corps, and emergency vehicles. This access road extends from the lower parking area south to Lock 19. It is 10' wide and constructed of concrete with curbs from the parking lot to just south of the tavern. The remainder is unpaved and undefined. The width in this southern section varies from 12 feet to more than 30 feet. The widest section of the road is due primarily to its use to store materials (Fig. 52). Also connected to the road are the wood plank bridge across the canal at Lock 19, and the towpath itself (Fig. 53).

The crossing at Lock 19 is one of the few that can support vehicular traffic. It is a crucial access point for emergency and maintenance vehicles. The Corps and the NPS occasionally transport small cranes and other necessary heavy equipment used in aqueduct, canal, towpath and boat maintenance along this route. The access road, bridge and towpath are also used to haul and repair the interpretive canal boats used in the park.

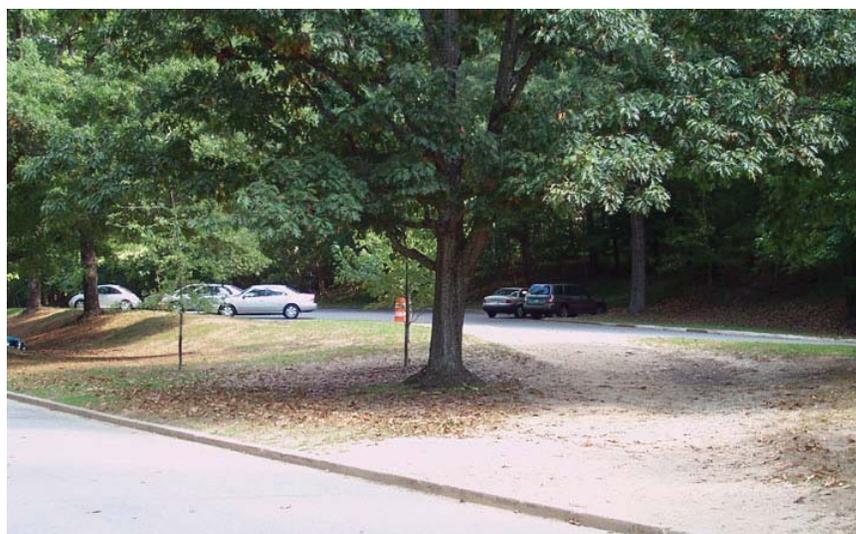
Figure 57 A heavily used volunteer trail leading from the Upper Parking Area to the Concession Stand (NCR CLP 2006).

Several volunteer trails have evolved on the site, resulting in erosion and compaction. One of the most prominent is from the upper parking lot to the concession stand, tracking across a grass area that is visually conspicuous from the rotary (Fig. 57). Another is used as the service access route across the lawn south of the tavern. Since materials are temporarily stored here and the area is used by vehicles and pedestrians, this area has become a large, non-vegetated compacted area stretching between the tavern and Lock 19. A third conspicuous social trail connects the observation roof of the inlet structure to the towpath.

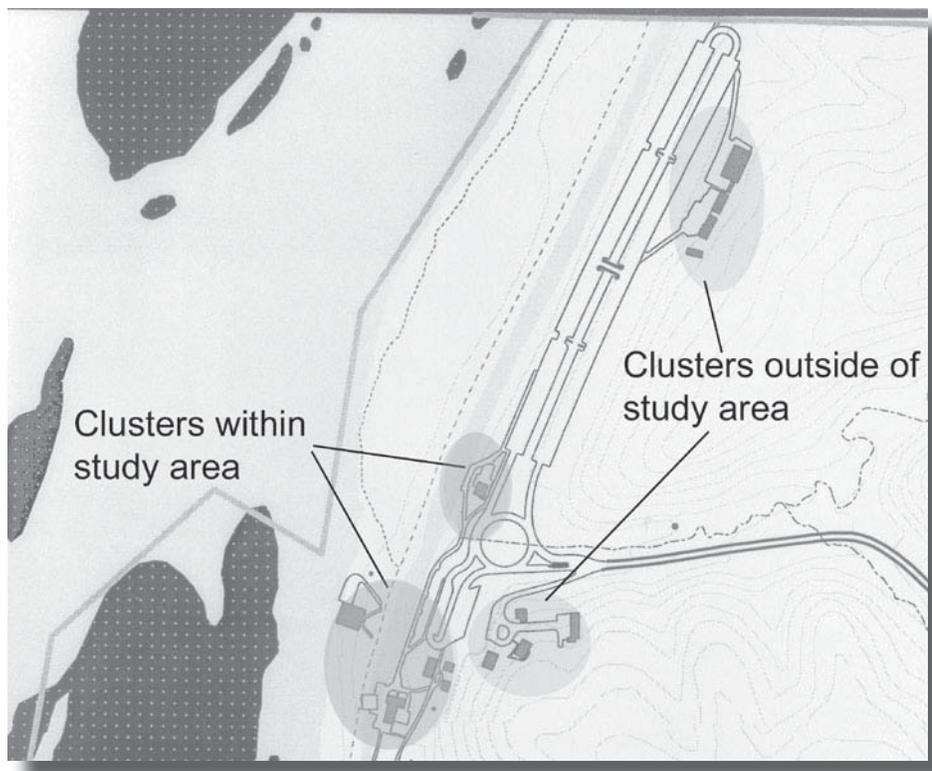
Figure 62 Building clusters within the GFT area

A second cluster, which is non-contributing, centers on the concession building at the northwest side of the rotary. Although there is only one building, the area includes a picnic ground, a brick-paved terrace and an array of walkways that connect the concession building with the upper parking area and the berm bank promenade (Fig. 62).

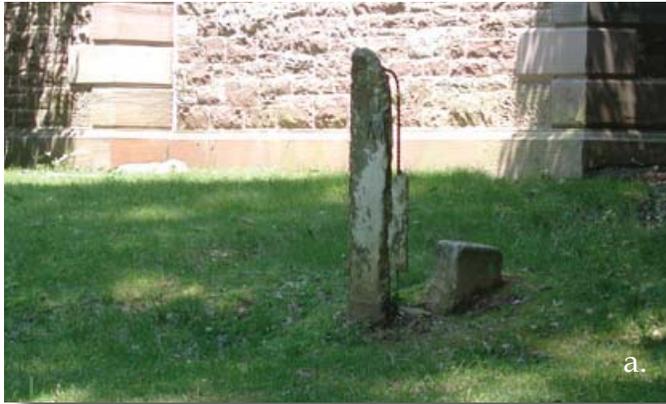
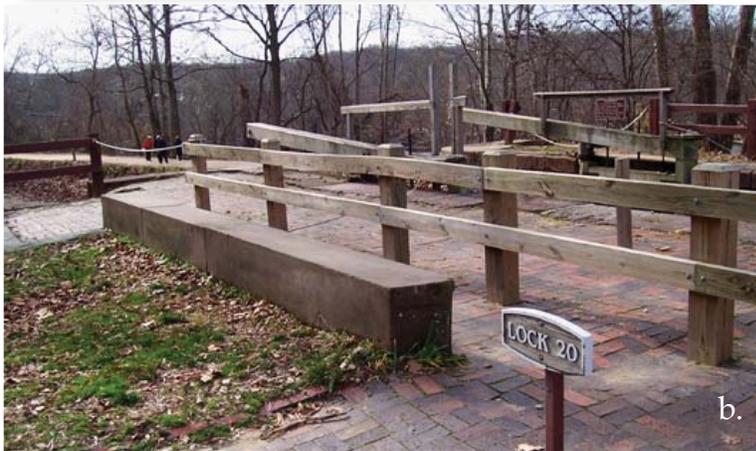
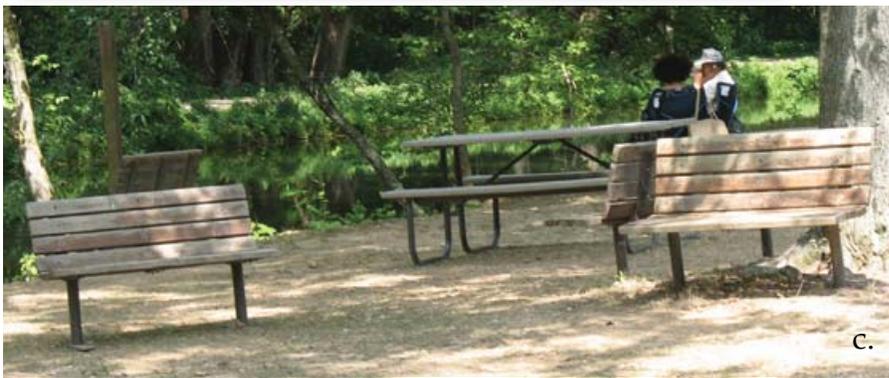
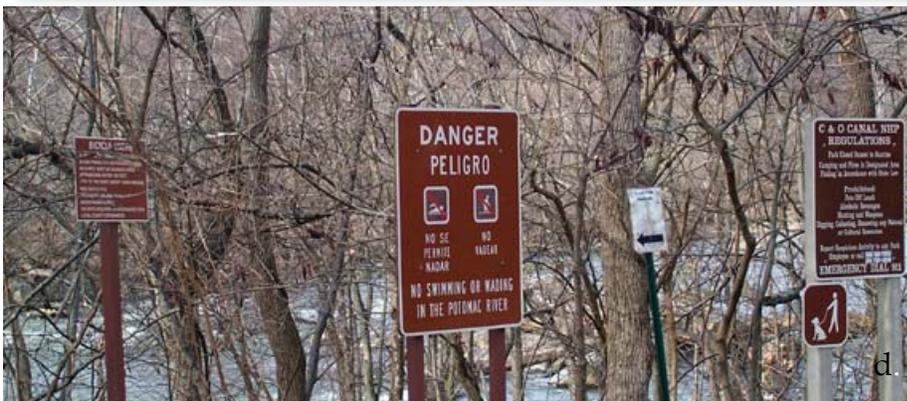
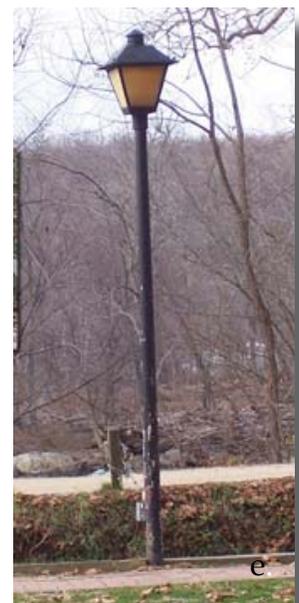
Figure 63 Some of the small scale features on site include a. Washington Aqueduct Engineer marker next to the gatehouse to the north of the tavern; b. fences and barriers such as those near Lock 20 as seen here; c. outdoor furnishing including benches and picnic tables; d. signage; e. lighting. Not pictured are the Washington Aqueduct survey and mile markers found along the entrance road (NCR CLP).

Many non-contributing or non-historic small-scale features exist on the site, such as signs, posts, curbs, lights, benches picnic tables, fences, barriers and kiosks (Fig. 63).

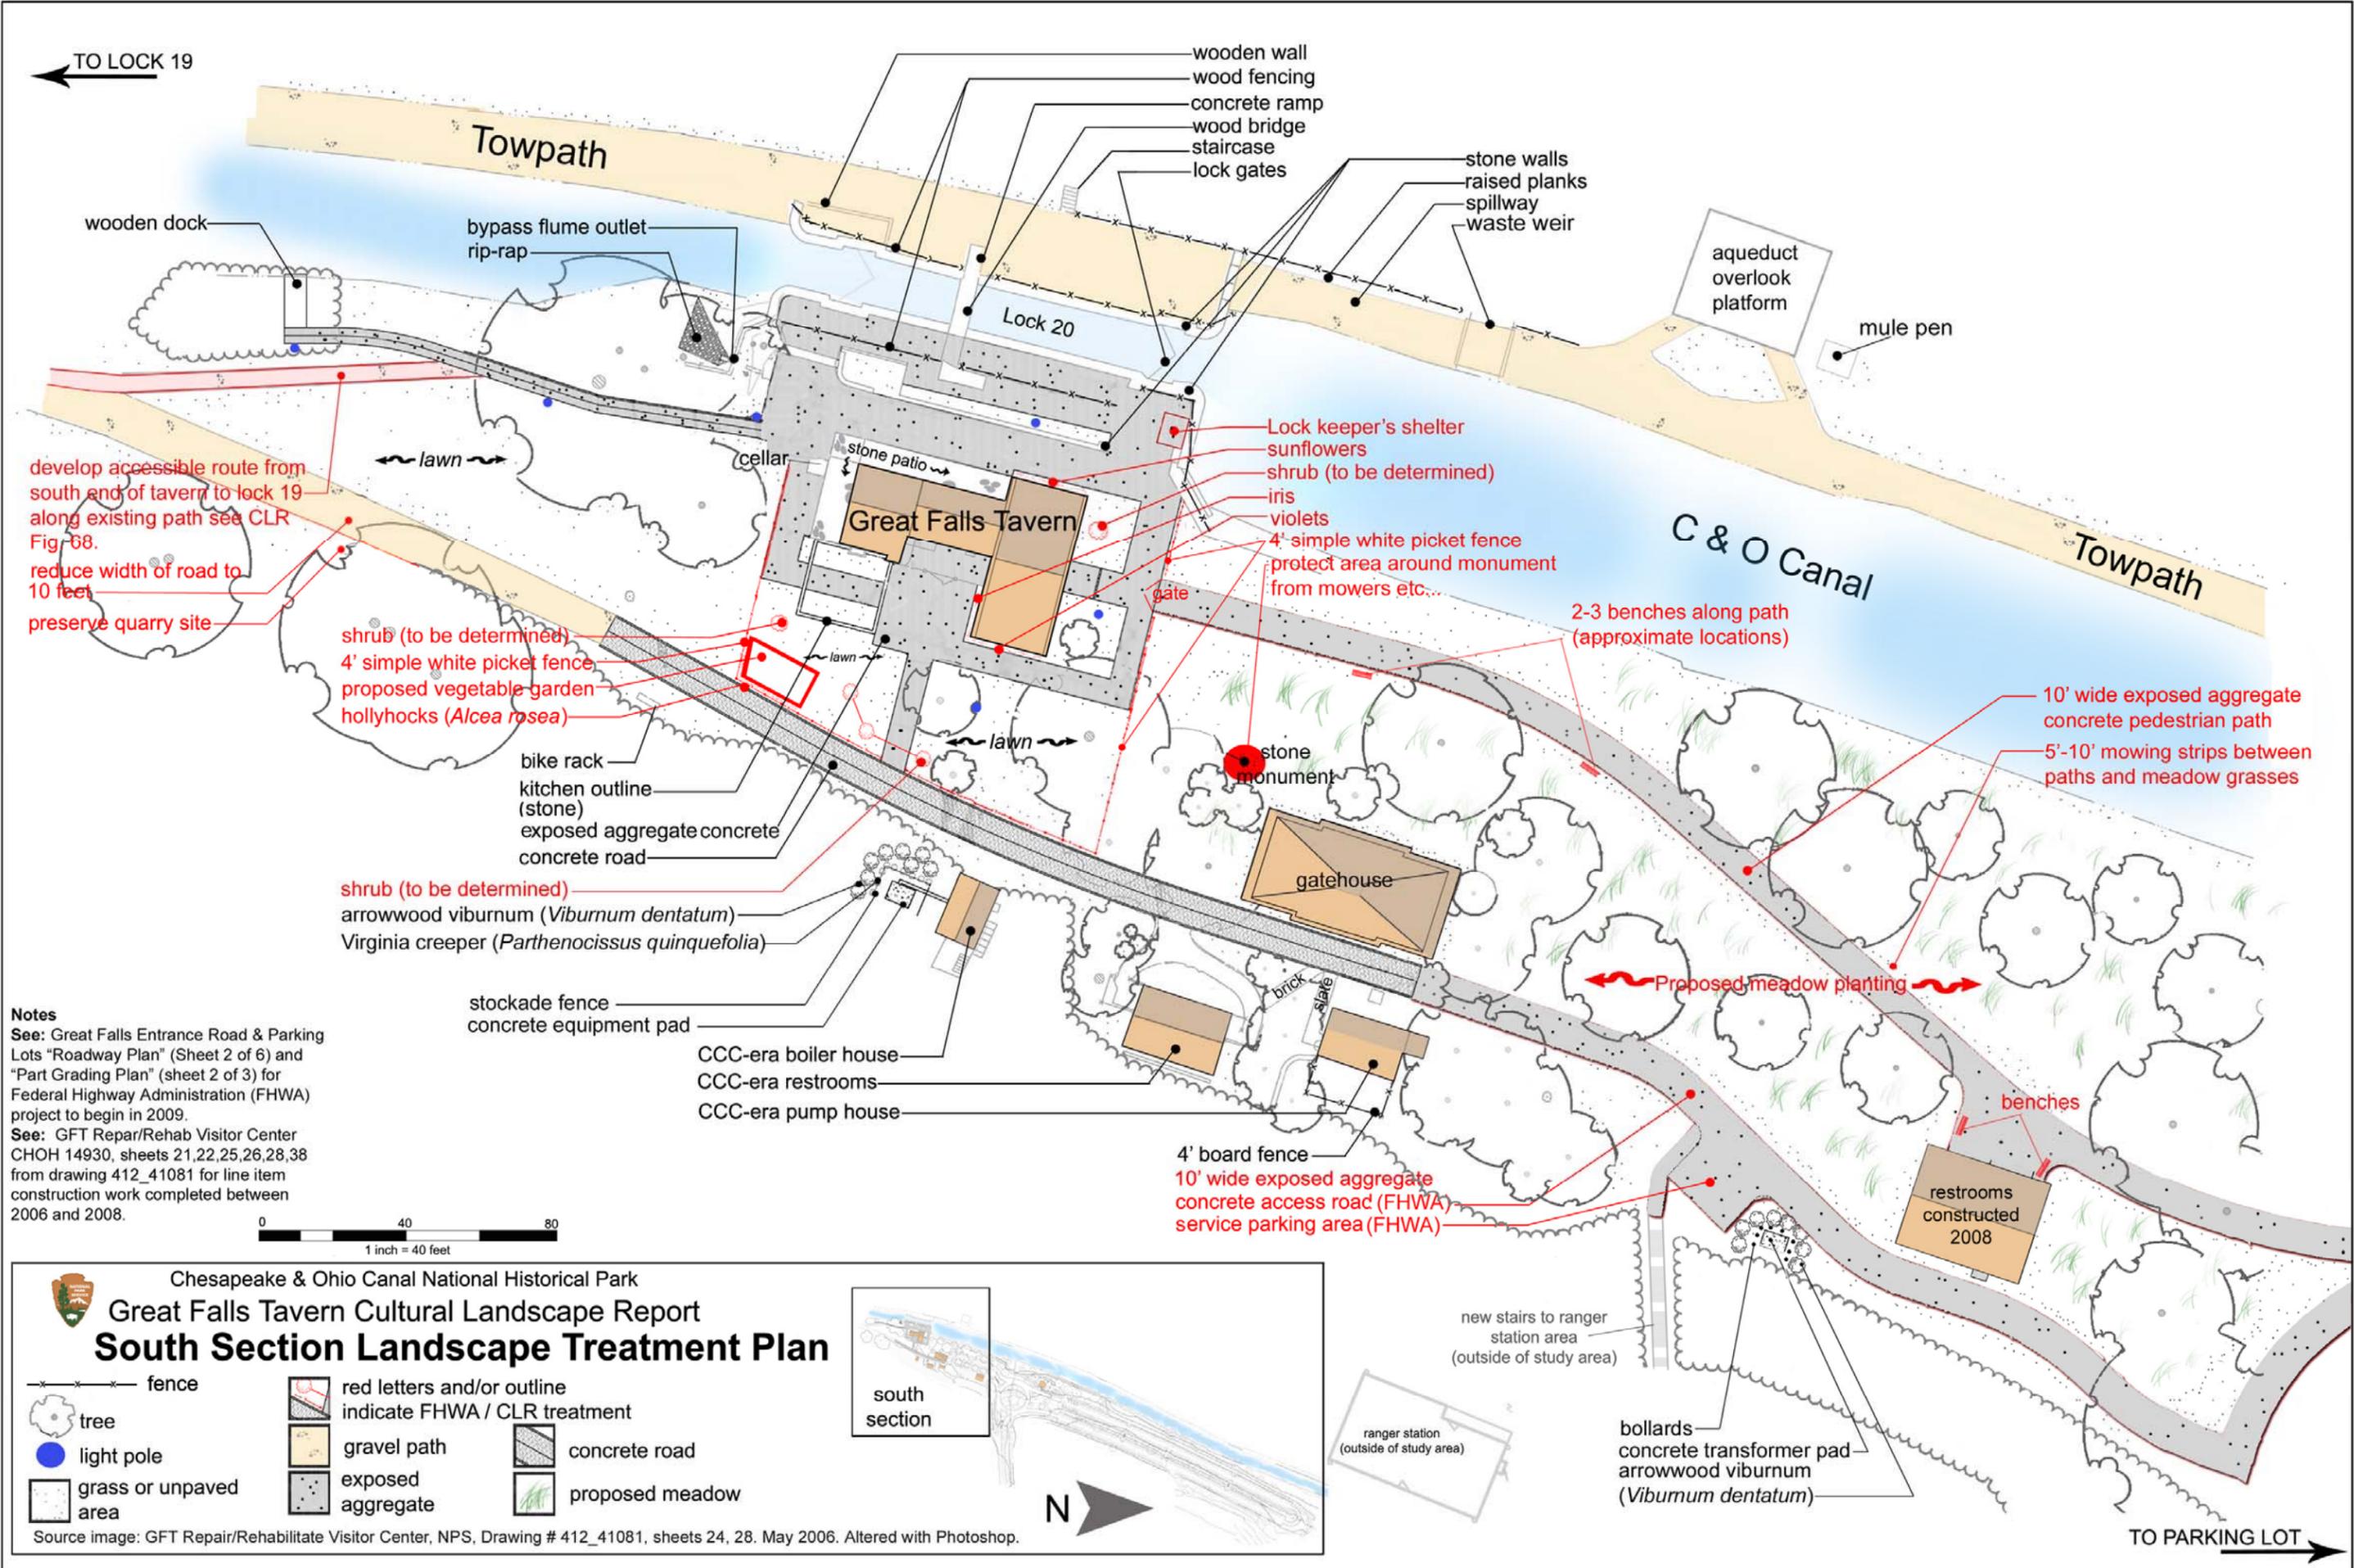
develop accessible route from south end of tavern to lock 19 along existing path see CLR Fig 68.
 reduce width of road to 10 feet
 preserve quarry site

Notes
See: Great Falls Entrance Road & Parking Lots "Roadway Plan" (Sheet 2 of 6) and "Part Grading Plan" (sheet 2 of 3) for Federal Highway Administration (FHWA) project to begin in 2009.
See: GFT Repair/Rehab Visitor Center CHOH 14930, sheets 21,22,25,26,28,38 from drawing 412_41081 for line item construction work completed between 2006 and 2008.

Source image: GFT Repair/Rehabilitate Visitor Center, NPS, Drawing # 412_41081, sheets 24, 28. May 2006. Altered with Photoshop.

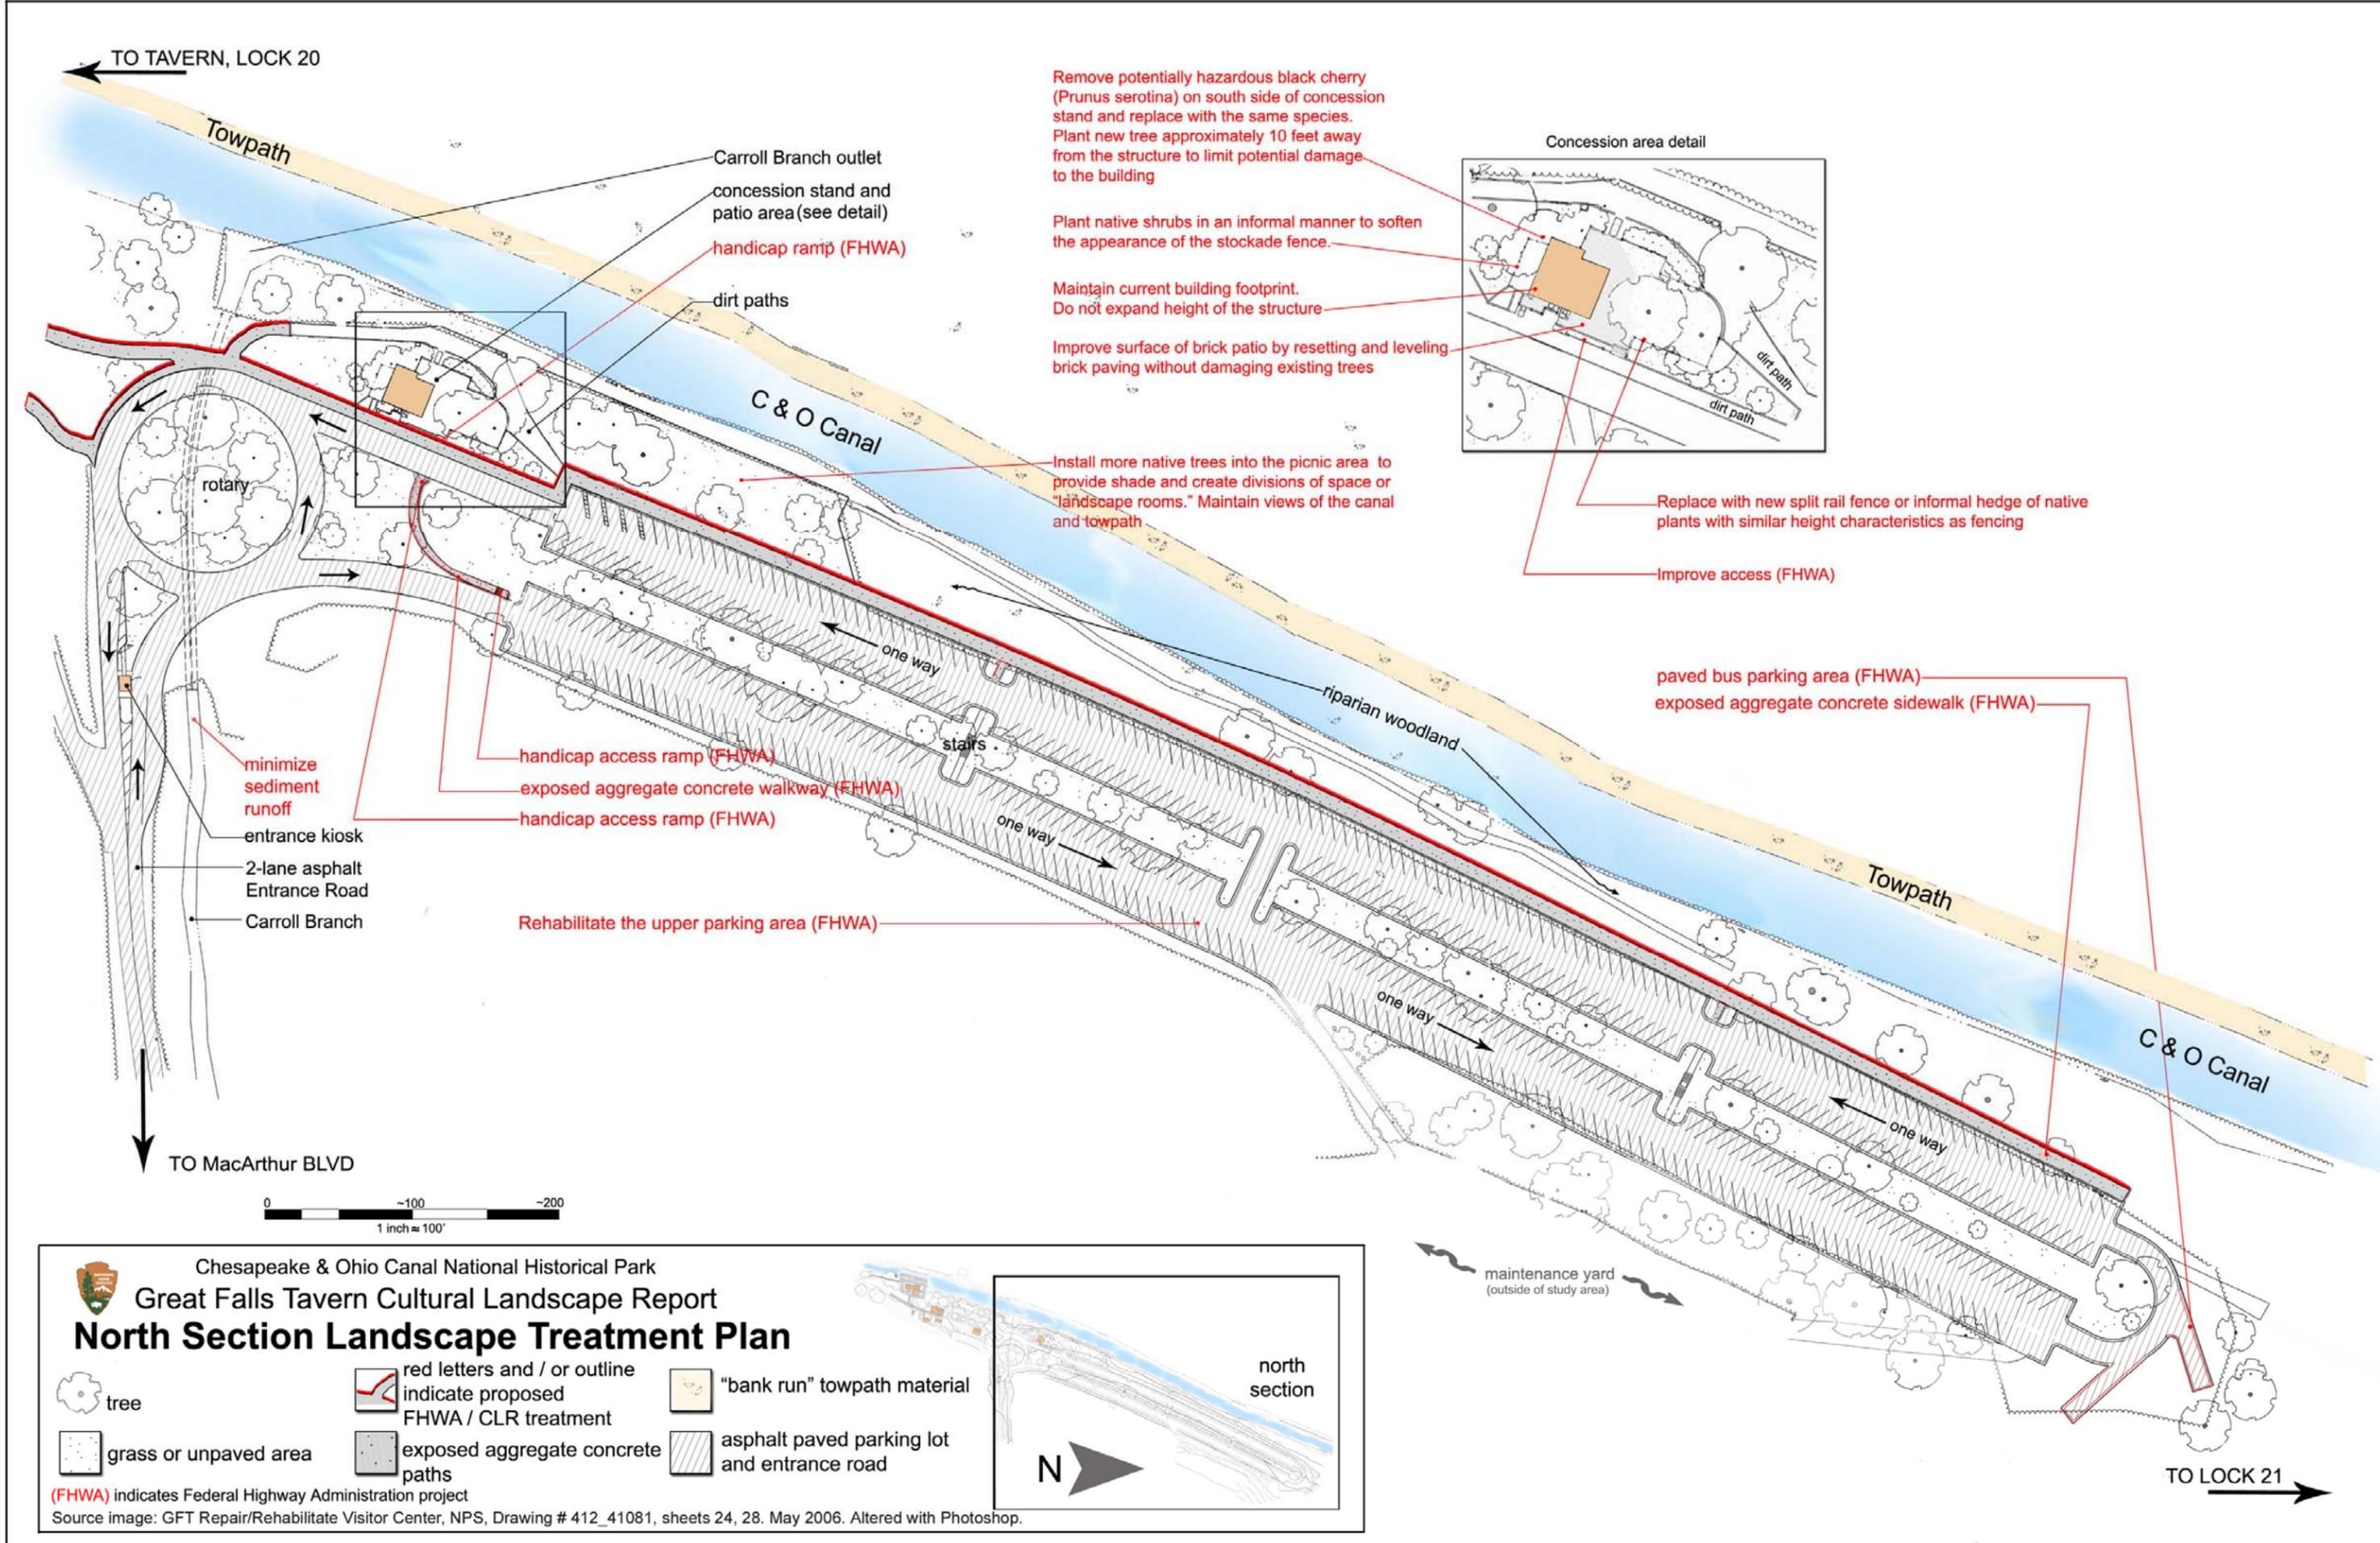
Remove potentially hazardous black cherry (*Prunus serotina*) on south side of concession stand and replace with the same species. Plant new tree approximately 10 feet away from the structure to limit potential damage to the building

Plant native shrubs in an informal manner to soften the appearance of the stockade fence.

Improve surface of brick patio by resetting and leveling brick paving without damaging existing trees

Install more native trees into the picnic area to provide shade and create divisions of space or "landscape rooms." Maintain views of the canal and towpath

(FHWA) indicates Federal Highway Administration project
Source image: GFT Repair/Rehabilitate Visitor Center, NPS, Drawing # 412_41081, sheets 24, 28. May 2006. Altered with Photoshop.

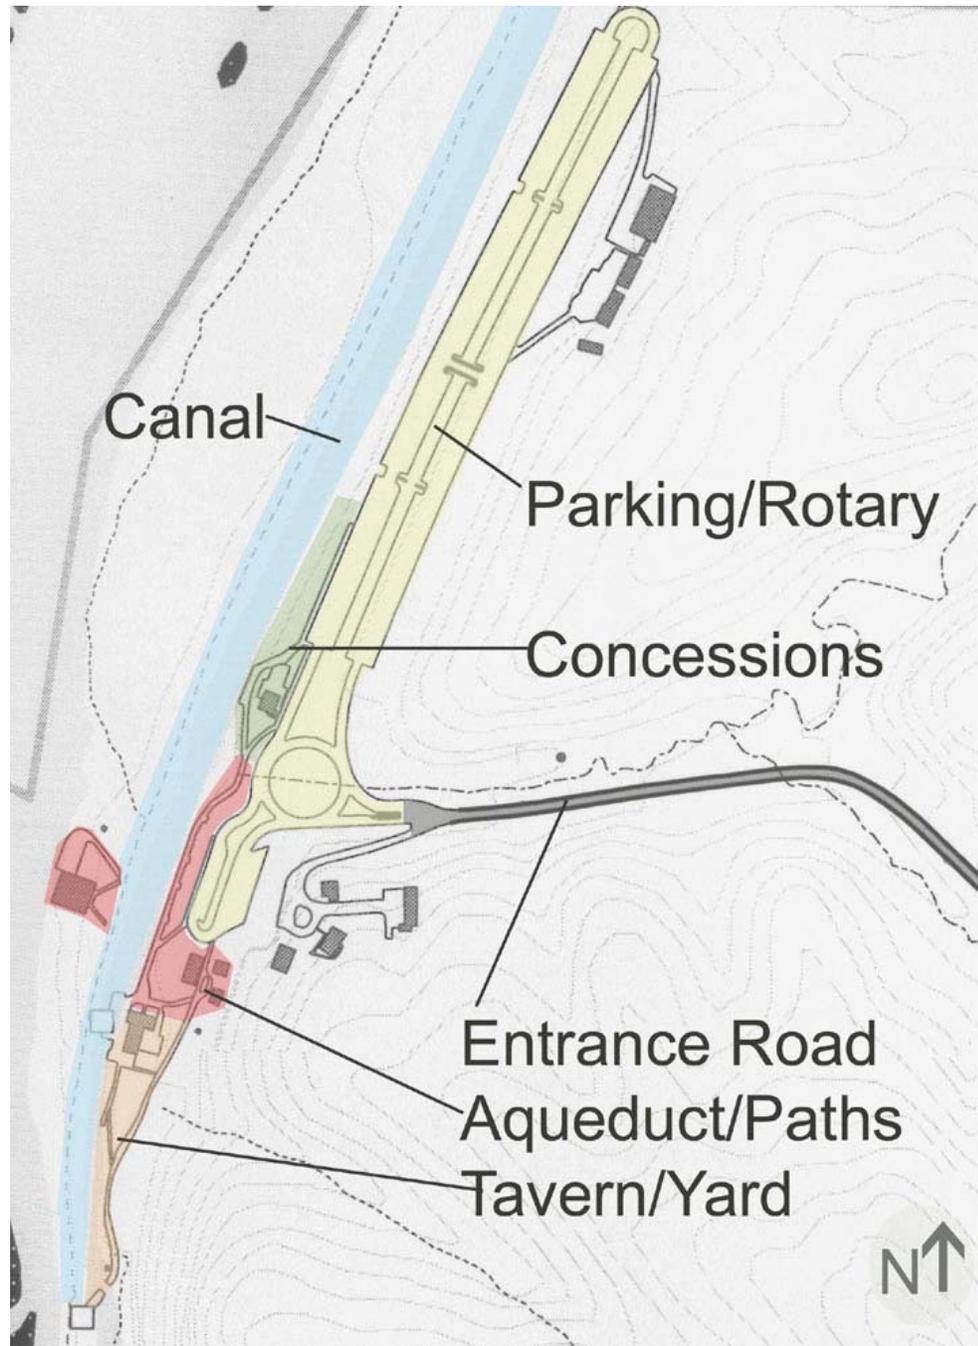
Figure 64 Landscape Character Areas (NPS).

Landscape character areas include the Canal, the Great Falls Tavern and Yard, the Washington Aqueduct and Paths, Concessions, Parking and Rotary and the Entrance Road (Fig. 64).

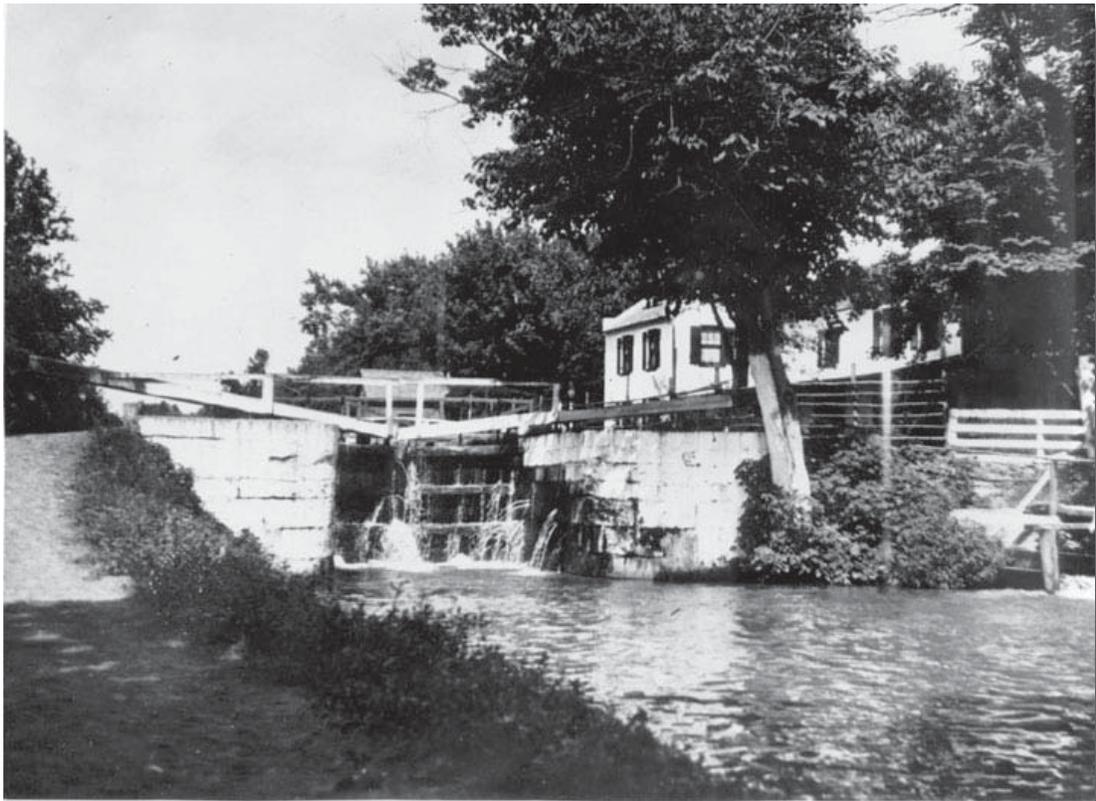
Figure 65 Whitewash is seen on both the lock and trees near the canal in this historic photo c. 1913 (CHOH Sharpsburg, Young and Jett).

Historically there were few small-scale built features along the canal, with the exception of whitewashed (See figures 65,) rocks and trees. Current extant small-scale features include directional and interpretive signs, lighting, outdoor furnishings and fencing.

- Evaluate advisability of whitewashing or painting rock outcrops, lock walls and trees in canal near locks as was done during historic canal operations (Fig. 65). (See appendix D).
- Remove all fencing along the canal north of the tavern (FHWA).
- Retain the lantern-style site lighting (wood post, replicated gas glass lantern).
- Remove all other light posts (**complete**).
- Minimize of use of signs along the canal.

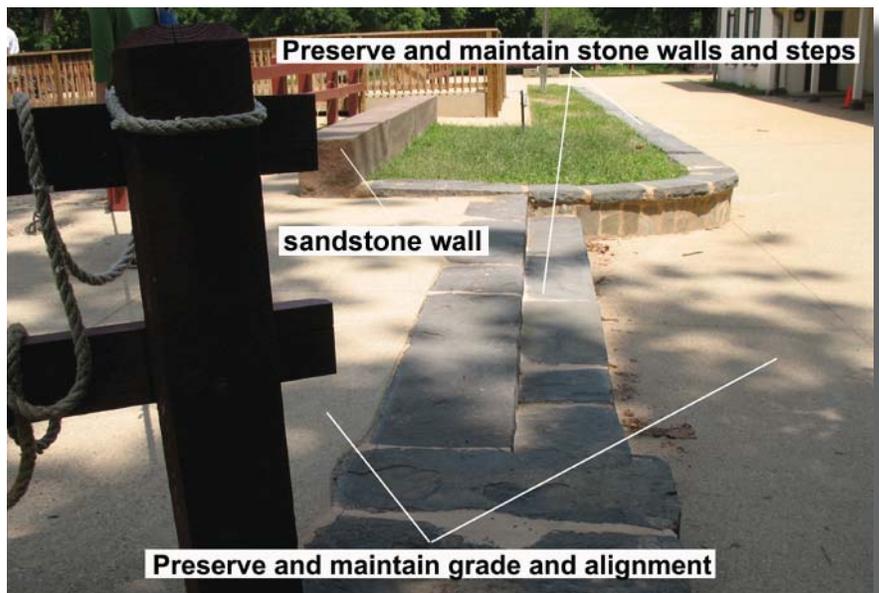
Figure 67 The grade, alignment, stone wall and steps are significant cultural resources at Lock 20 (NCR CLP 2006).

- Preserve and maintain existing stone wall and steps along by-pass flume alignment and elevation changes adjacent to the lock wall. Preserve and maintain red sandstone block wall (Fig. 67).

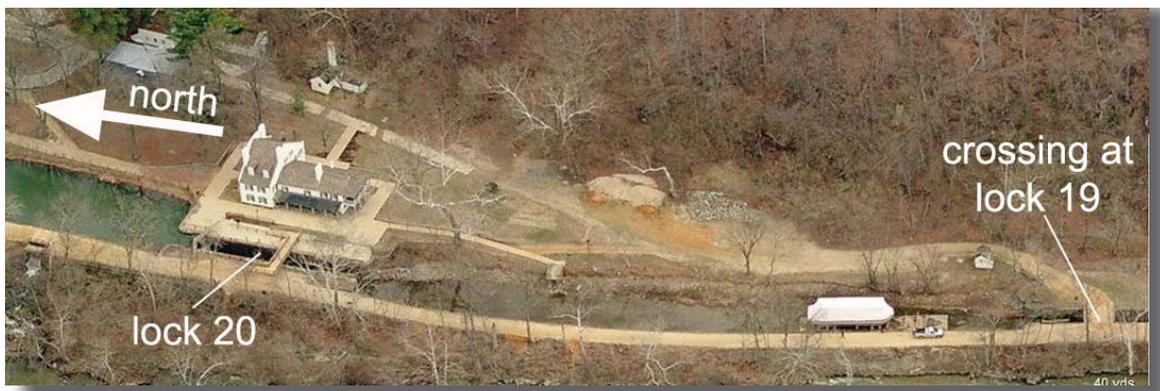
Fig 68 Great Falls Tavern is situated at lock 20. An accessible path from the south side of the tavern to lock 19 would allow visitors to cross the canal when lock 20 is unavailable (source bing.com/maps 2009).

- Reduce pavement width of plaza to 12-feet across the front of the south porch (**complete**).
- Re-align path south to canal boat dock to ensure pedestrian access; remove timber curbing (**complete**).
- Remove the volunteer path across the lawn south of the tavern. If this route is needed for temporary movement of storage materials, repair it quickly to minimize erosion and loss of ground cover.
- Collaborate with regional landscape architects to develop an accessible path from south side of tavern to lock 19 so visitors can cross canal when lock 20 crossing is unavailable.

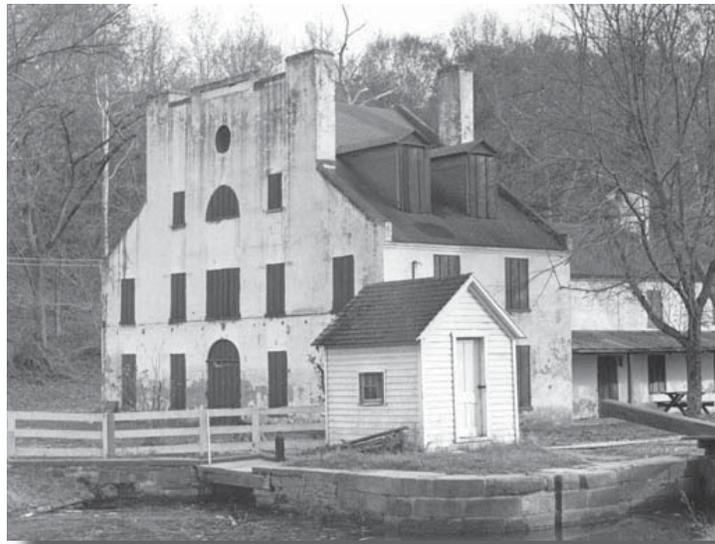
Figure 69 1946 photograph of the Lockkeeper’s shanty at Lock 20 (NPS, CHOH Sharpsburg. Abbie Rowe).

- Construct historic kitchen “footprint” in tavern’s east yard by outlining the former location with stone that is laid flush with the ground. This will provide a better sense of the spatial arrangement of this private working space to visitors (**complete**).
- Construct a replica of the Lockkeeper’s shanty to recreate the historic scene. It should be placed at the upstream, north-east corner of Lock 20 where the former building stood (See Fig. 69).

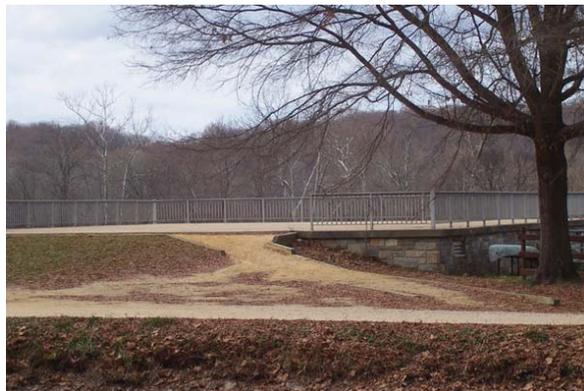
Figure 70 Northern approach to viewing platform atop intake structure (NCR CLP 2006).

The roof of the intake control structure is adjacent to the towpath. It is open to park visitors, and allows views to the dam and the Potomac River. Although the intake structure on the west side of the towpath was designed to minimize intrusions on the historic landscape, it is a prominent feature when viewed from the berm bank on the opposite side of the canal (Fig. 70).

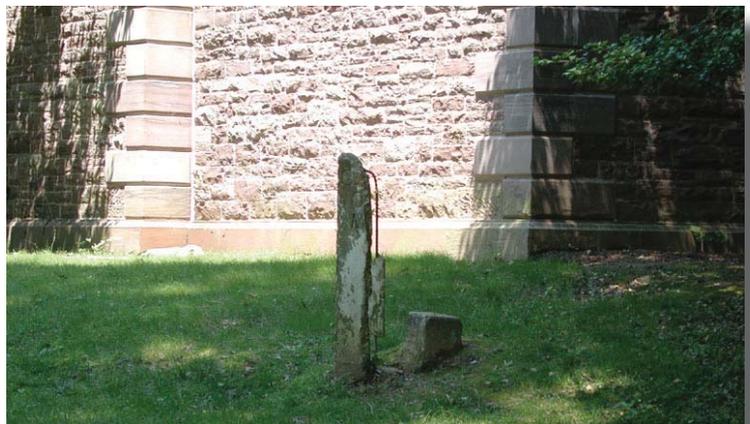
Figure 71 (below) Survey marker and stone mile marker near the Control Gate House (NCR CLP 2003).

During the late 19th century and through the 1930s, white-painted picket fences surrounded and set off property managed by the U. S. Army Corps of Engineers, including the control gatehouse. One of the most historically significant features on the entire site is located within this sub-area. It is an inscribed mile marker related to construction of the aqueduct, and is thought to derive from the original aqueduct construction period of 1853-1867 (Fig. 71). A smaller inscribed concrete survey marker believed to have been installed between the years of 1853 and 1877 accompanies the marker. Both structures are listed on the List of Classified Structures (LCS) as National Historic Landmarks.

- Conserve the survey and stone mile markers near the gatehouse, including the grades around them.
- Mow grass within at least a 3-foot radius around stone mile markers and maintained it at a low height so markers will be visible to visitors and maintenance personnel.
- Remove all picnic benches and non-contributing furniture from the vicinity of the gatehouse.
- Remove non-contributing fencing (**FHWA**).
- Minimize use of signs in area; use vegetation or varied path widths and materials to guide visitors through this area.
- Install historically appropriate benches along new pathway facing the canal.

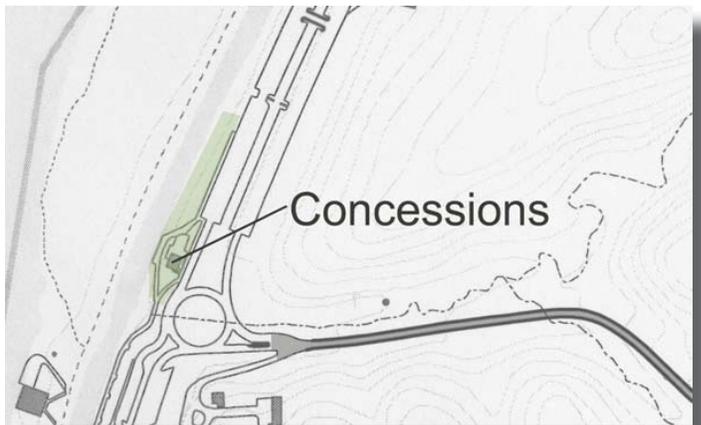
The picnic ground, located directly north of the concession stand, is a fairly open space edged by forest canopy on the north and west sides, and the concession stand and terrace to the south. To the east is a pedestrian walkway that separates it from the parking area. Within the grounds are a limited amount of tall trees above a compacted ground plane. There are no formal paths within the area.

The concession building and surrounding terrace were designed and built by the NPS in the 1950s. Both remain in the same location as when they were built and are highly visible from the park entrance.

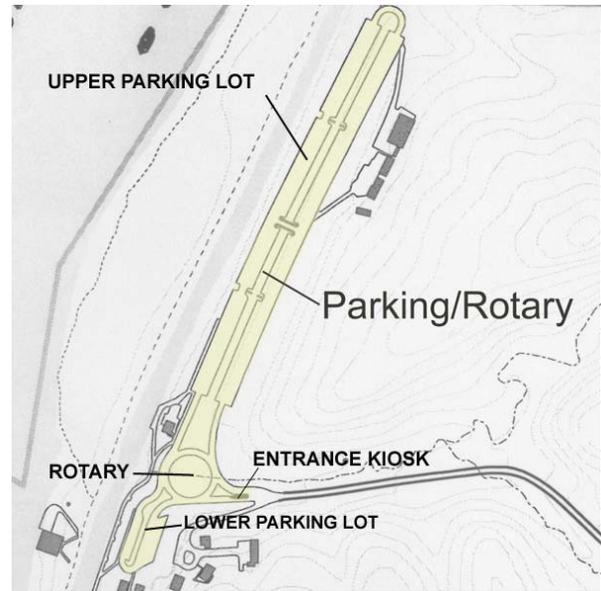
The parking areas were designed by the NPS in the 1940s on two levels each with one-way aisles to fit within the shape of the original parcel purchased by NPS as an extension of the George Washington Memorial Parkway (GWMP) in 1944 (See Fig 26). The layout and dimensions of the lots are the same now as when they were paved and graded in the mid 20th century. Lot elevations extend from 190 feet at the northeast side of the upper parking area to about 155 feet at the bank on the south side of the tavern with a gradient of 2 percent in a little less than a half mile.

The rotary design derives from plans for a parkway along the canal. The rotary feature is seen in several forms in numerous preliminary iterations of landscape development for the site prepared by the NPS during the 1940s (See Fig. 29). Rotaries had been a popular element of NPS planning since the late 1920s, when loops and rotaries were tools used by NPS planners to manage traffic flow and promote safety. Within the parks, they are found at the end of roads, overlooks and viewpoints, parking areas and inter-sections.

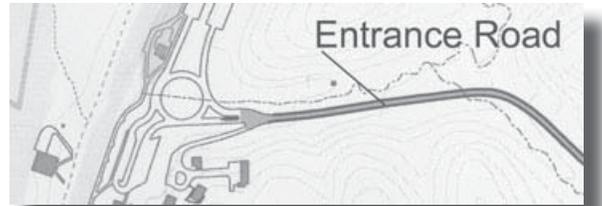
Originally built to serve the Washington Aqueduct, and long known as Conduit Road, this popular historic roadway has carried tourists to Great Falls since 1875, replacing the earlier Old Rockville Road. The road measured 16 feet wide when it was macadamized in 1916. In the 1970s, the road width was expanded to 20 feet. Graded paved shoulders, paved drainage ditches and concrete culverts were also installed during this time. Several sections of the road were designed to drain to adjacent forested wetlands which feed Carroll Branch. The road is also a favorite bike route for a circuit ride along MacArthur Boulevard to the tavern and back.

The road retains the historic alignment of the early to mid- 20th century and blends in with the rolling topography and forested slopes of the adjacent Gold Mine Tract. Important adjacent historic resources including the Maryland Mine and the rail bed of the Chevy Chase to Great Falls Trolley Line can be easily viewed from the road corridor, and are historically associated with it. Most of the following recommendations are being followed by the pending FWH A project.

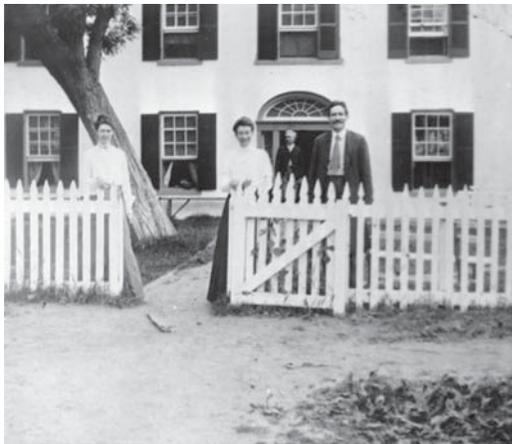
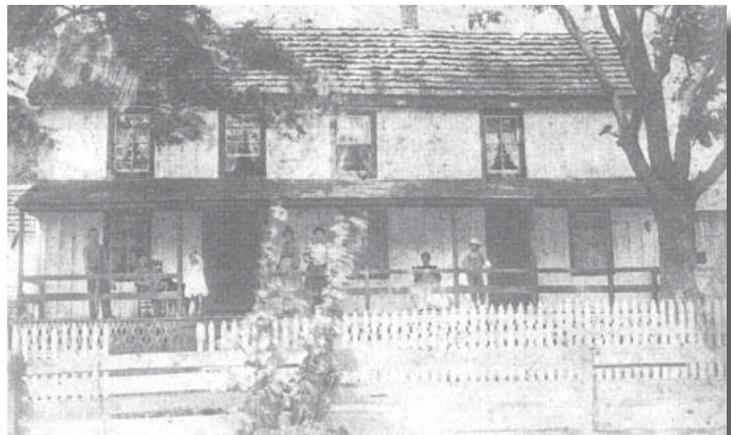
Picket fences were commonly seen along the canal during its heyday. On the left, a whitewashed picket fence is seen in this 1902 photograph taken on the north side of the tavern. The photo on the right is an image of Lock 56 in 1890 ([left] CHOH Sharpsburg, Young and Jett, 4 [right] CHOH archives).

Fences and walks around the Great Falls tavern have undergone several changes during their existence. Prior to the Civil War, and in the post war era, a breast high white picket fence enclosed a small rectangular yard along the northern wing, being located about 25 feet from the line of the building. At a point on a line with the eastern side of the northern wing, the northern fence formed a right angle, and extended southward to the edge of the building. The western end of the northern fence was joined at a right angle by another section of pickets, which extended southward along the western side of the building, about mid-way between it and the lock. Another picket fence enclosed the space between the northern and southern wings on the eastern side of the building. Between 1913 and 1925, while the tavern served as a private club, a head high post and rail fence enclosed the entire tavern lot; and the existing board fences are of more recent origin. The original walks around the tavern, of which there is one remaining example extending from the western portion to the lock, were of brick. The slate or stone walls on the eastern side of the tavern were laid between 1913-1925....¹

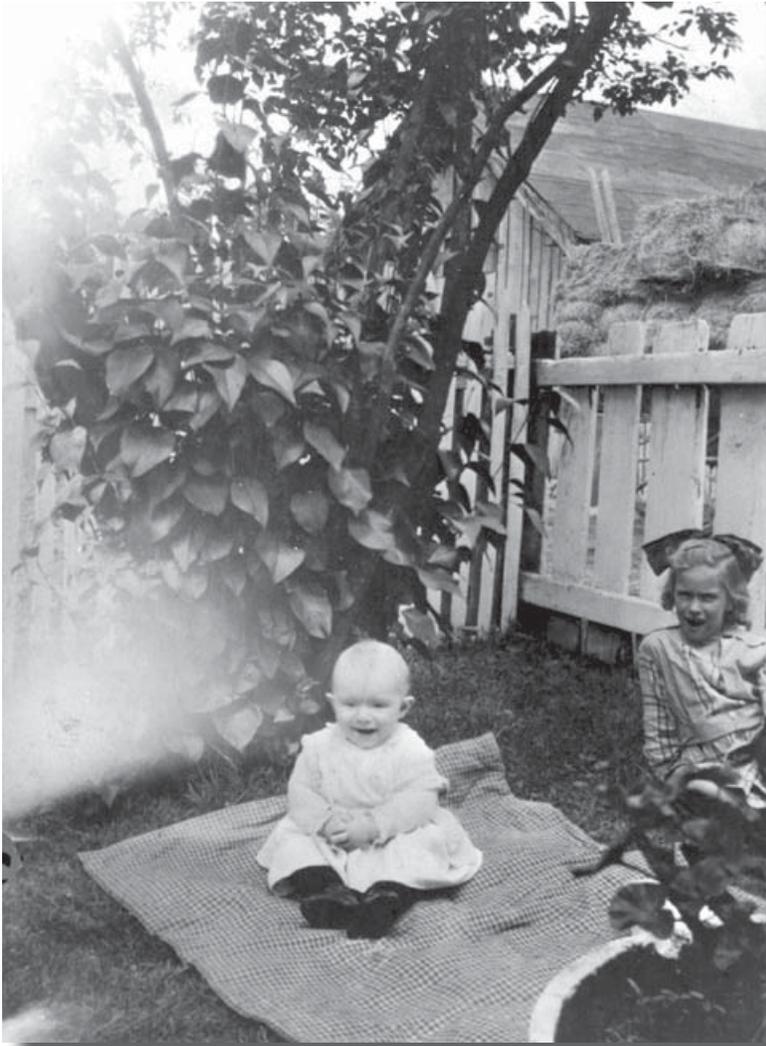
This photograph, presumably from near the turn of the century was taken at Lock 48. Behind the child on the lawn, and in front of the white picket fence, is a lilac bush. The potted plant in the foreground is a geranium (CHOH archives).

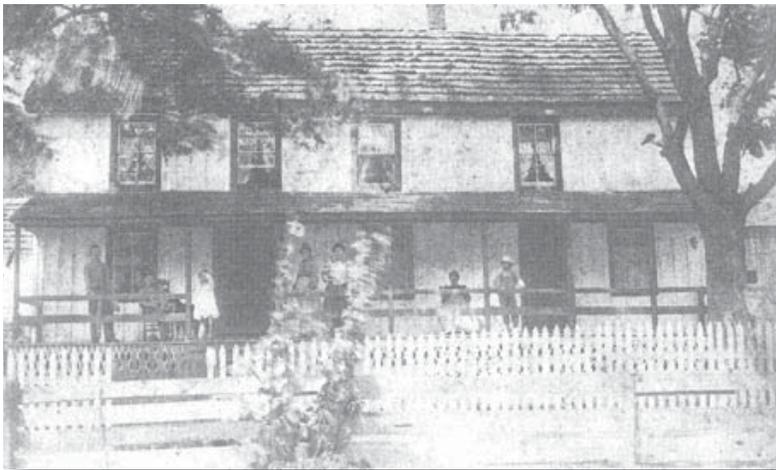
This 1890 image is of Lockkeeper Thomas F. Donegan and family at Lock 56. The lockhouse landscape is stark and it is partially divided by a white picket fence. In the foreground, hollyhocks flutter in the breeze (CHOH archives).

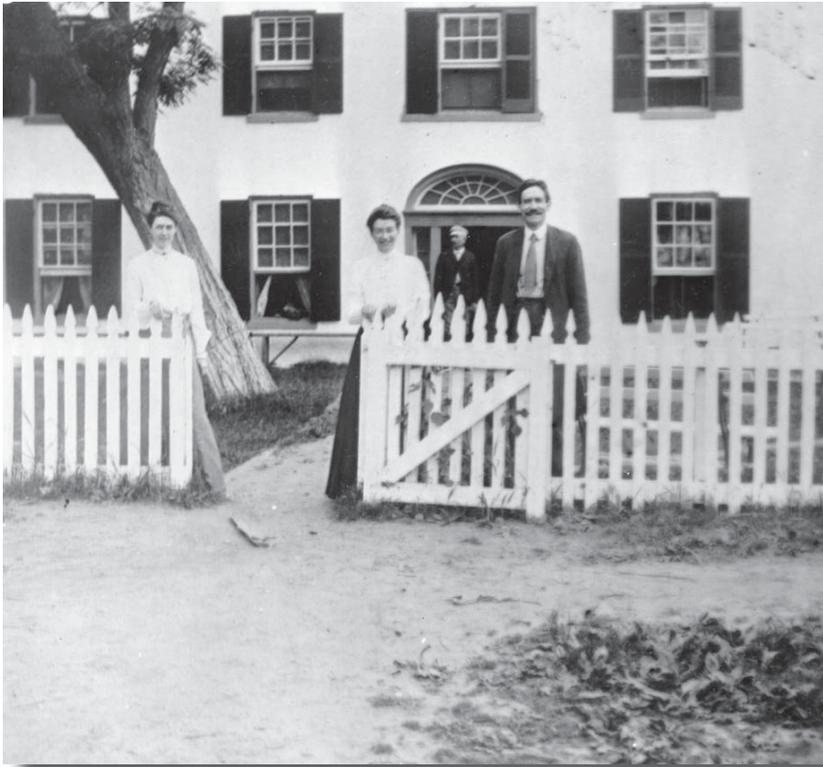
This photograph of the north entrance of the tavern from 1902 illustrates the stark nature of the tavern. Behind the white picket fence, a whitewashed tree is surrounded by turf, and the walkways appear to be composed of compacted soil (CHOH Sharpsburg, Young and Jett, 4).

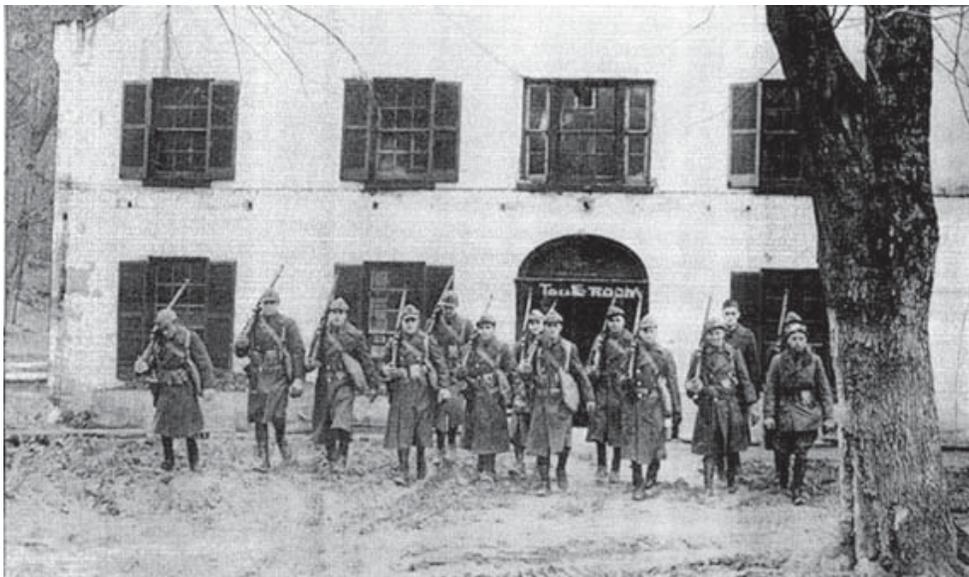
This 1915 photograph of the tavern was likely taken shortly after a 1914 flood. The ground plane appears uneven and the whitewash on the tree in the foreground appears to have been washed off (CHOH archives).
