GREAT FALLS TAVERN

Cultural Landscape Report

U.S. Department of the Interior
National Park Service
National Capital Region
Cultural Landscapes Program
Washington, D.C.
September 2009

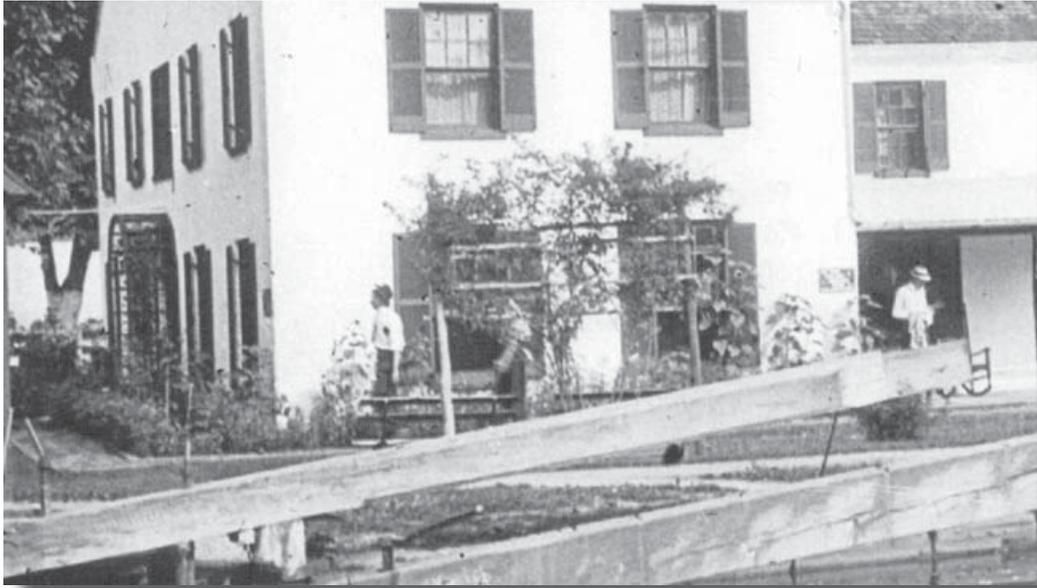
The 1917 photograph above shows vines on trellises, sunflowers along the west wall of the tavern and plantings of flowers or vegetables on the north side of the tavern. While the image was taken outside of the period considered the "heyday" of the canal, sunflowers could be considered for a modern tavern planting plan (CHOH archives).

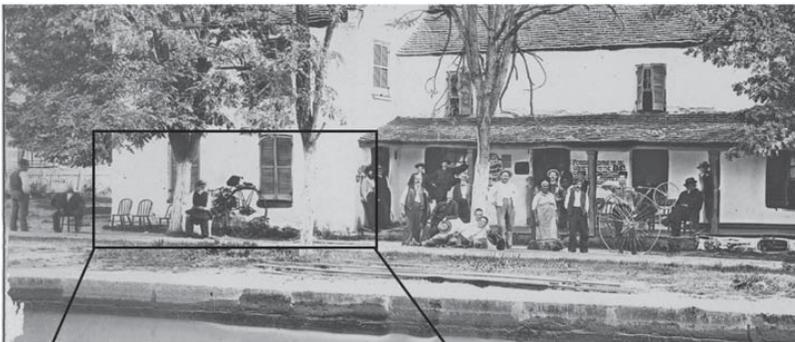
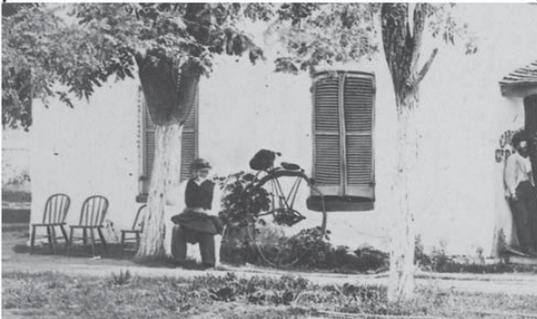
The photograph to the left is not dated but pre-dates the 1917 photograph above. Plantings on the west side of the tavern can be seen more clearly in the enlargement below. Whitewashed trees line the canal and landscaping is minimal, even "weedy." The enlarged section below shows, sunflowers may have been growing in the bed of soil along the west side of the tavern (MLK library HIC 154403).

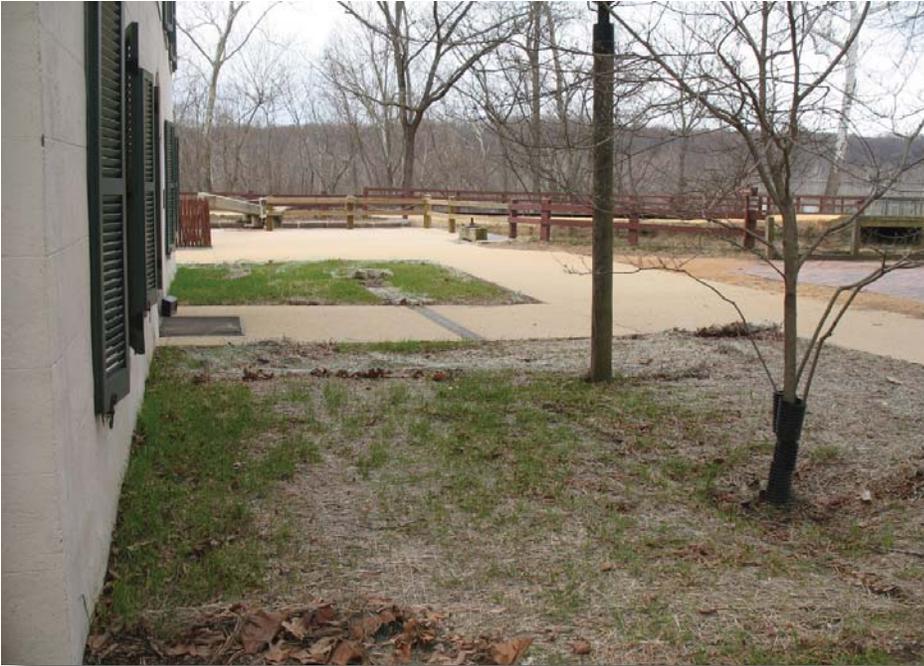
When adding plants to the landscape, consideration should be taken to avoid blocking the northern face of the tavern from the entry walk. Pots set on the grass on either side of the door filled with period annuals and / or perennials would provide foliage and flowers without obstructing views or access to the tavern door (NCR CLP 2008).

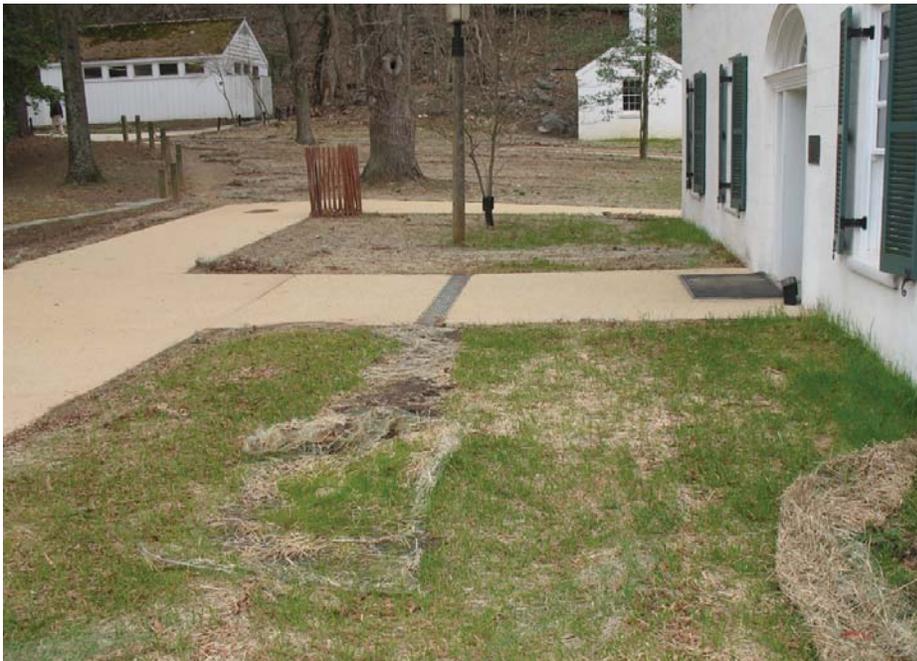
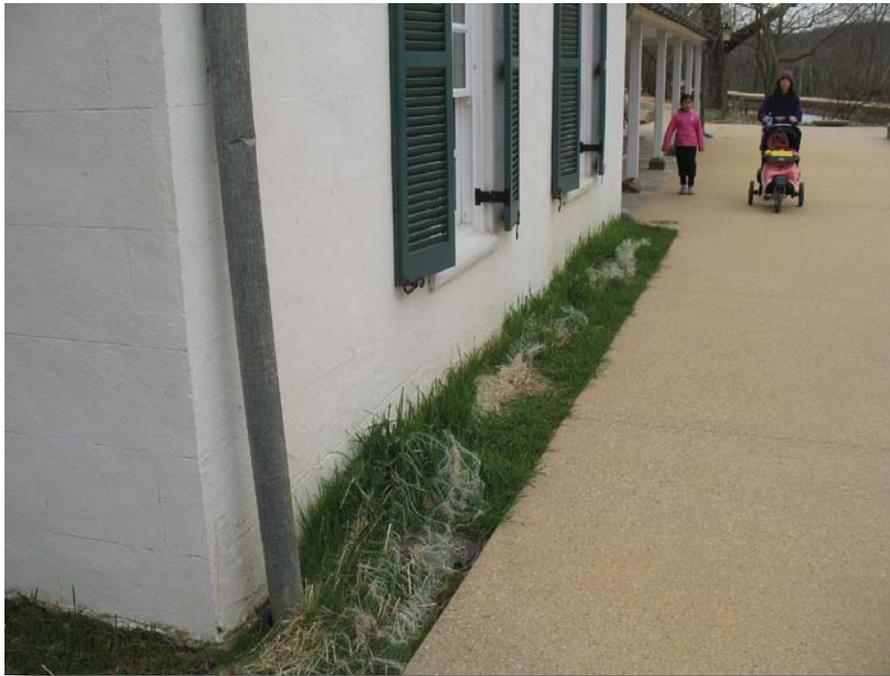
The grass in the bed on the west side of the tavern should be removed and a leaf mulch, gathered on-site, should be used both as a soil amendment and a top-mulch. Sunflowers could then be planted in the bed as they have been in the past (NCR CLP 2008).

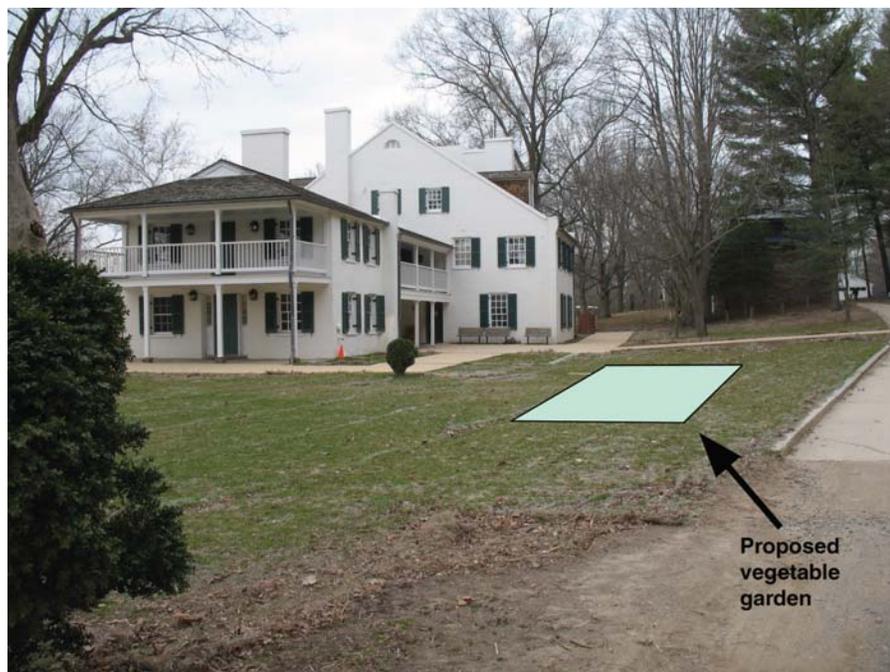
Without blocking the view of the southern façade of the tavern from the towpath or from the service drive, the addition of a limited number of shrubs would evoke the historic landscape.

This photograph also shows the general location of a proposed interpretive vegetable garden. The garden would be planted with heirloom vegetable varieties that would likely have been grown during the historic period (NCR CLP 2008).
